A Damage Resistance Comparison Between Candidate Polymer Matrix Composite Feedline Materials

TECHNICAL MEMORANDUM

1. AGENCY USE ONLY (Leave Blank)	2. REPORT DATE September 2000	3. REPORT TYPE AND DATES COVERED Technical Memorandum		
4. TITLE AND SUBTITLE A Damage Resistance Comparison Between Candidate Polymer Matrix Composite Feedline Materials			5. FUNDING NUMBERS

9. SPONSORING/MONITORING AGENCY NAME(S) AND ADDRESS(ES) National Aeronautics and Space Administration Washington, DC 20546-0001			10. SPONSORING/MONITORING AGENCY REPORT NUMBER NASA/TM-2000-210482

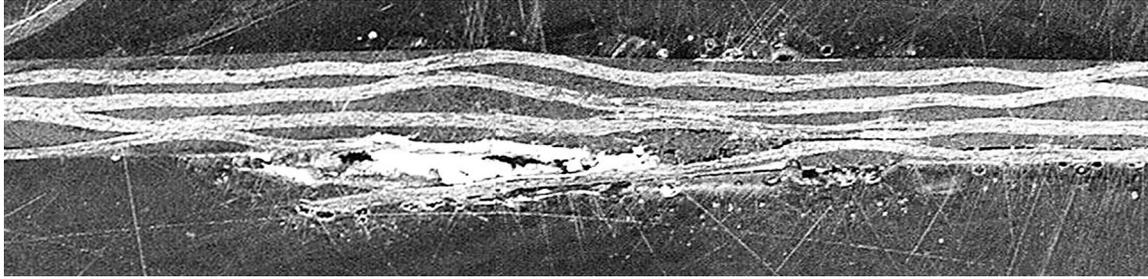
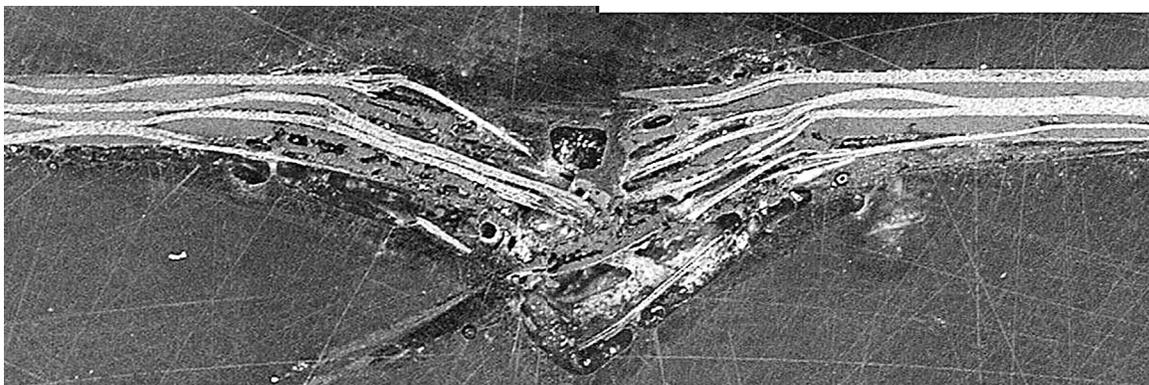
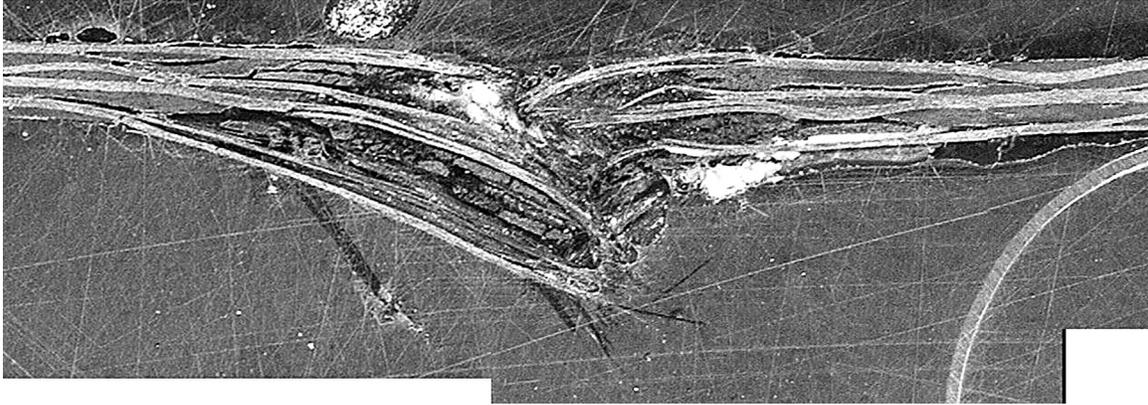
Figure 4 shows photomicrographs of the cross section of each type of resin system tested at the high-impact energy level. The 977-6 and PEEK resins appear to have far less damage than the others tested. The Cycom 823 and RS-E3 resins show near penetration.

Figure 4. Cross-sectional photomicrographs of specimens impacted at 2.5 ft-lb.

Figure 4. Cross-sectional photomicrographs of specimens impacted at 2.5 ft-lb (continued).

After the specimens were x-rayed, they were sectioned through the center of the impact area with a diamond-wafering blade. The halved specimens were then mounted in polymethylmethacrylate for subsequent edge polishing and microscopic examination. The specimens were sectioned parallel to the warp fibers on the outer surfaces of the specimens, or parallel to the outer 0° fibers on the IM7/PEEK specimens. The edges were wet polished with silicon-carbide paper of progressively finer grit sizes: 240,

400, 600, 800, 1000, and 1200. A fluorescent dye was placed on the polished edges of the specimen and wiped off so that the dye remained in any cracks in the specimen. Upon exposure to an ultraviolet light source, any damage present would then be highlighted and much easier to detect.

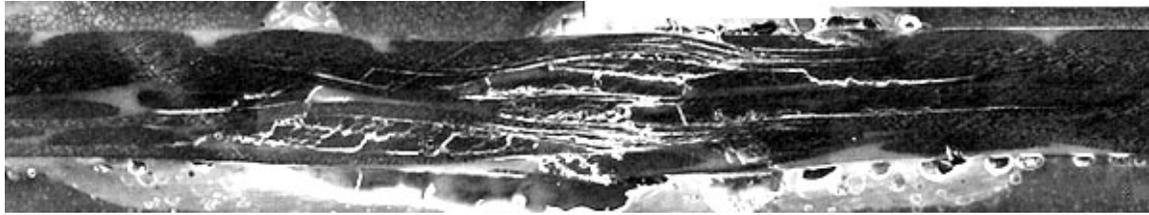
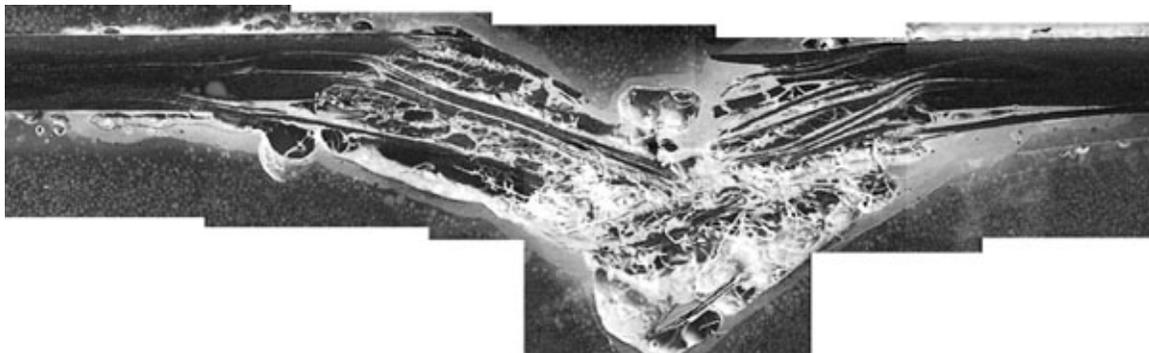
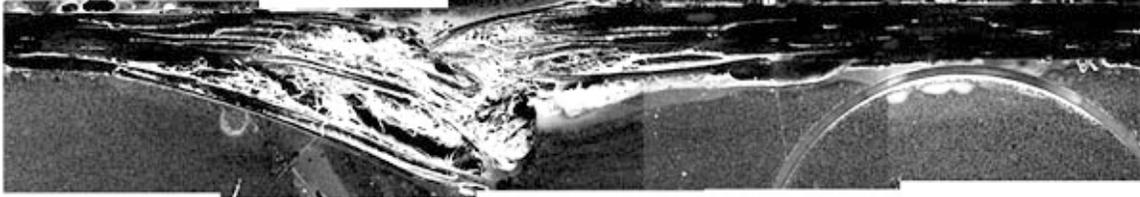
Figure 5 shows fluorescent-dye-enhanced photographs of these cross sections. This technique better shows the extent of damage present in the specimens. The 977-6 specimen only has two short delaminations near the outer plies and minor fiber breakage on the top ply. The plies in the center of the specimen appear to be completely undamaged. The PEEK specimen shows good damage resistance; however, damage exists throughout the thickness of the specimen. The severity of damage to the Cycom 823 and RS-E3 resin systems are even further highlighted by the fluorescent dye. The PR 520 resin system had delamination and matrix cracking within all plies, although the photograph in figure 4 does not clearly show this and is a good argument for using a fluorescent dye penetrant even on samples where damage is readily visible.

Figure 5. Cross-sectional photomicrographs of specimens impacted at 2.5 ft-lb, fluorescent dye enhanced.

Figure 5. Cross-sectional photomicrographs of specimens impacted at 2.5 ft-lb, fluorescent dye enhanced (continued).

The use of a fluorescent dye to highlight damage gives a better indication of damage when examining the cross section of an impacted specimen.

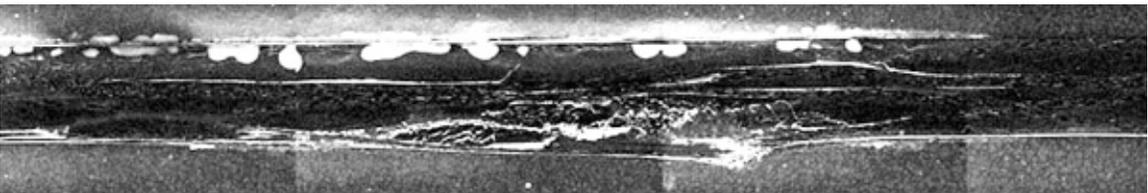
Figure 8 shows photomicrographs of the cross sections of each type of resin system tested at the low-impact energy level. The fluorescent dye technique was employed on all of these specimens since visible light did not readily detect all of the damage present. The 977-6 and the PEEK resins showed the least damage as they did for the high-impact energy level. The 977-6 resin showed a short delamination at the bottom plies and some matrix cracking within the bottom ply, but the majority of the cross section was undamaged. The PEEK resin showed similar damage with some small delaminations and matrix cracking in or near the bottom ply.

The RS-E3 resin system had extremely long delaminations emanating from the impact damage, so two pictures are presented to include the entire range of damage.

Figure 8. Cross-sectional photomicrographs of specimens impacted at 1.8 ft-lb.

Figure 8. Cross-sectional photomicrographs of specimens impacted at 1.8 ft-lb (continued).

From the results in this study, it appears that the 977-6 resin system is far superior to the others tested for microcracking resistance to impact damage. The PEEK resin system also demonstrated good impact resistance. The Cycom 823 and RS-E3 demonstrated poor impact resistance as many delaminations and microcracks were found in these specimens at the low-impact energy level.
