High-Speed Observer: Automated Streak Detection for the Aerospike Engine

TECHNICAL MEMORANDUM

HIGH-SPEED OBSERVER: AUTOMATED STREAK DETECTION FOR THE AEROSPIKE ENGINE

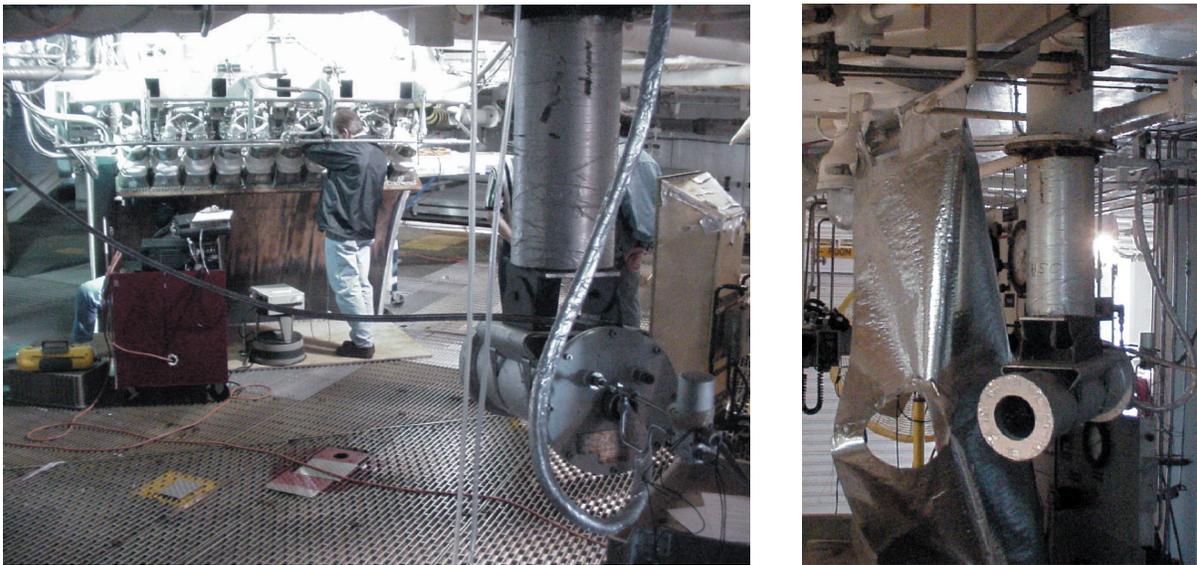
Figure 1. HSO camera and aerospike engine at SSC.

The basic HSO system uses a 200-frames per second (fps), 256×256 pixel DALSA[®] CCD array camera to generate 8-bit gray scale digital images. This camera is mounted inside a PELCO[®] EHX6-12 explosion-proof housing for protection against the rugged environment experienced during testing. The HSO camera position at SSC used for single-engine testing is shown in figure 1. The current HSO system uses a dual Intel Pentium[®] Pro 200-MHz computer running Microsoft Windows[®] NT with a BitFlow, Inc. Road Runner frame capture board to process images in real time. Each image frame is encoded with interrangle instrumentation group (IRIG) timing and recorded on a 17.2-gigabyte (GB) redundant array of inexpensive disks (RAID) system. After testing, images are stored on an 8-mm Exabyte[®] tape and shipped to Marshall Space Flight Center (MSFC) for posttest analysis.

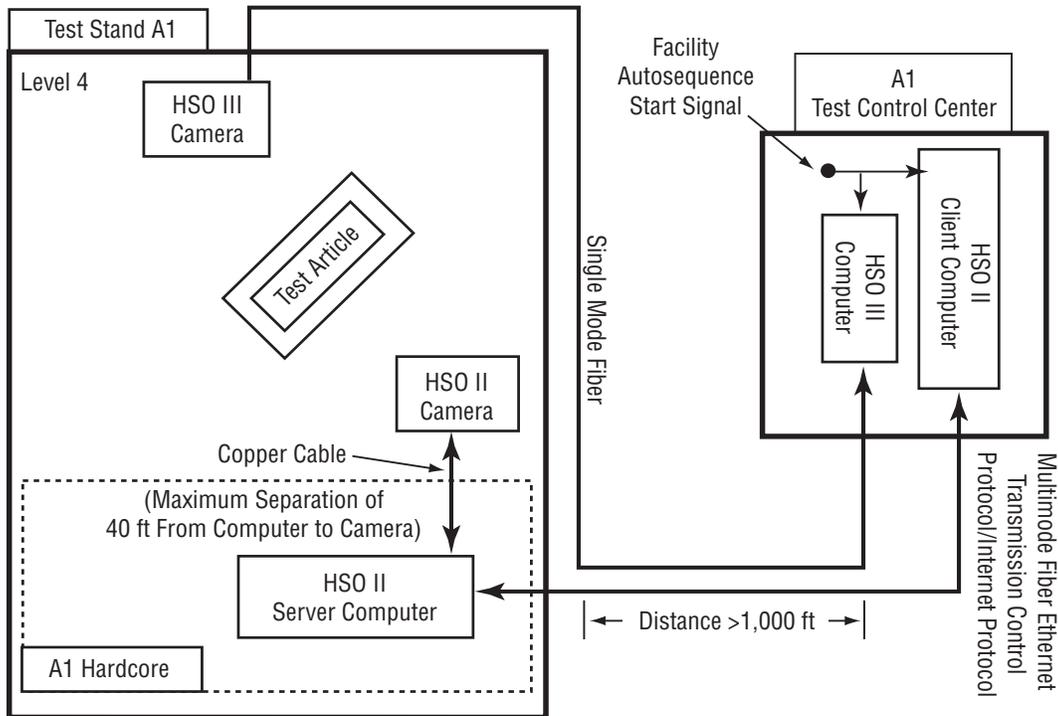
Figure 2. HSO hardware configurations.

The aerospike engine configuration differs significantly from that of an SSME. Modifications to the method of operation of the HSO were made to accommodate engine differences. At present, only one side of a single module of the engine (cover photo) is being monitored for anomalous plume streaking with only one operational camera (HSO II) as shown in figure 2. Another camera (HSO III) will be added when the full-up configuration of the aerospike engine (two of the modules shown in the cover photo) is tested.

- (2) Repositioning of the HSO server system and camera—The HSO camera position at SSC for aerospike engine tests has been changed from the position of the last series of SSME tests. The ideal camera position on the test stand would be perpendicular to the line of combustors and on or slightly above a plane horizontal with the midpoint between combustor exit planes and the edge of the ramp. Although, the view angle from the camera to the combustors is not a right angle, making a head-on view unavailable, it is sufficient to provide separation of combustor plume areas. The height positioning of the camera provides the necessary single line of reference at the combustor exit plane for the region of interest.

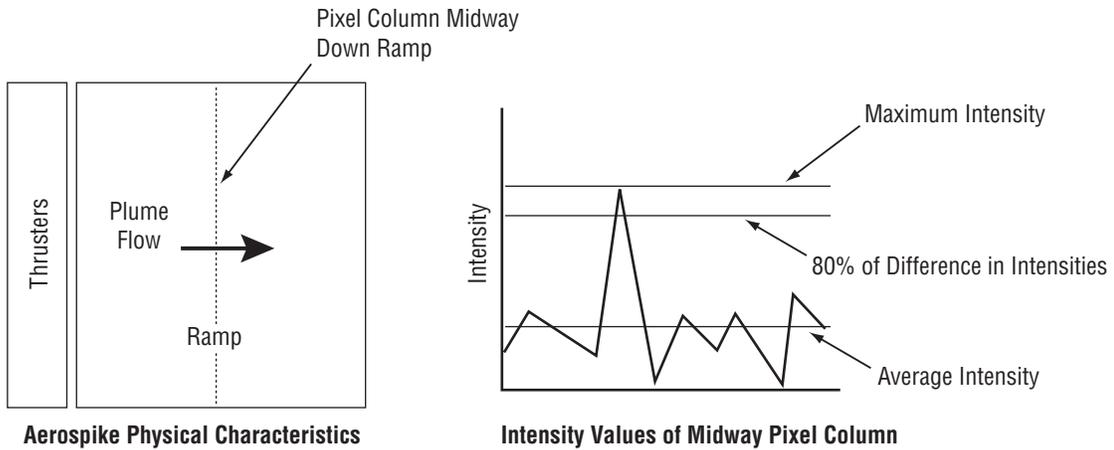
Figure 3. Control value intensity determination for an image frame.

To account for these differences, a new streak detection algorithm was created. First, a control intensity value for streak detection is determined for each frame (fig. 3):

1. A column of pixels midway down the ramp from the thrusters to the end of the ramp is chosen to be a control column.
2. An average of the pixel intensity values along the column, which are less than the “wash-out” intensity of a bloom region, is obtained.
3. A maximum of the pixel intensities, which are less than the wash-out intensity of a bloom region, is also obtained.
4. The control intensity value for detecting streaks is determined as 80 percent of the difference from the average to the maximum intensity.

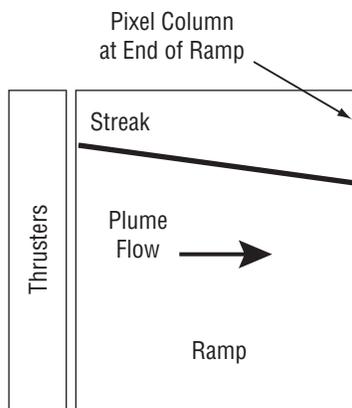
Figure 4. Candidate streak selection.

Next, candidate streak seed points are chosen from local maxima along a row of pixels at the edge of the ramp (fig. 4):

1. Along the column of pixels at the end of the ramp area, local maxima are consecutively selected and tested.
2. If a local maximum value is not greater than the control intensity, it is not considered as a candidate for a streak.
3. If a local maximum value is greater than the control intensity, a streak growth algorithm, using local greatest intensity values is initiated.

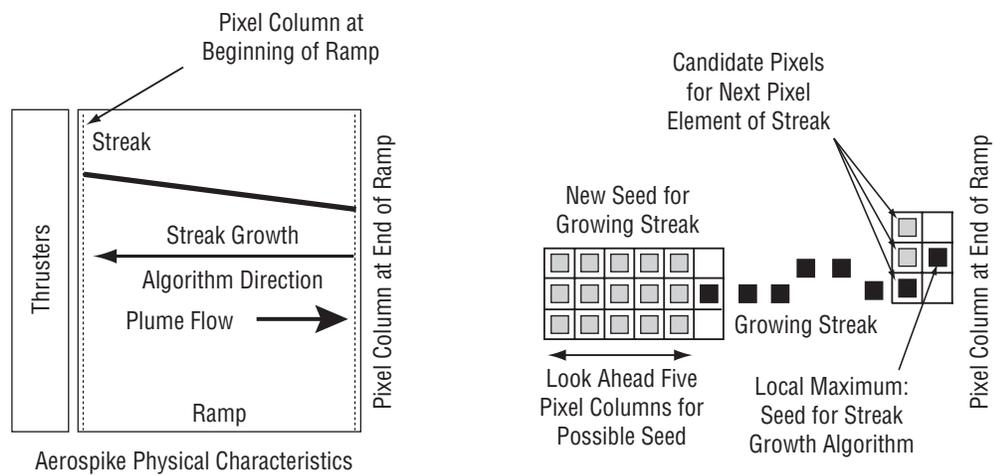
Figure 5. Streak growing algorithm.

Candidate streaks are grown from local intensity value maxima in the pixel column at the end of the ramp (fig. 5):

1. Local maximum intensity values above the control intensity value provide initial seeds for the growth algorithm.

2. Three adjacent pixels in the streak growth direction; i.e., toward the thrusters, are tested.
3. The pixel with the highest value within 15 percent or above the control intensity value is chosen as the next seed pixel.
4. If all three pixels have intensity values <15 percent of the control value, the next three adjacent pixels are tested. This process is repeated up to five times. If no seed pixel is detected, the streak growth is ended and the next local maximum in the pixel column at the end of the ramp is inspected.
5. If the column of pixels near the thrusters is encountered, the algorithm labels the starting local maximum as a streak generating pixel.

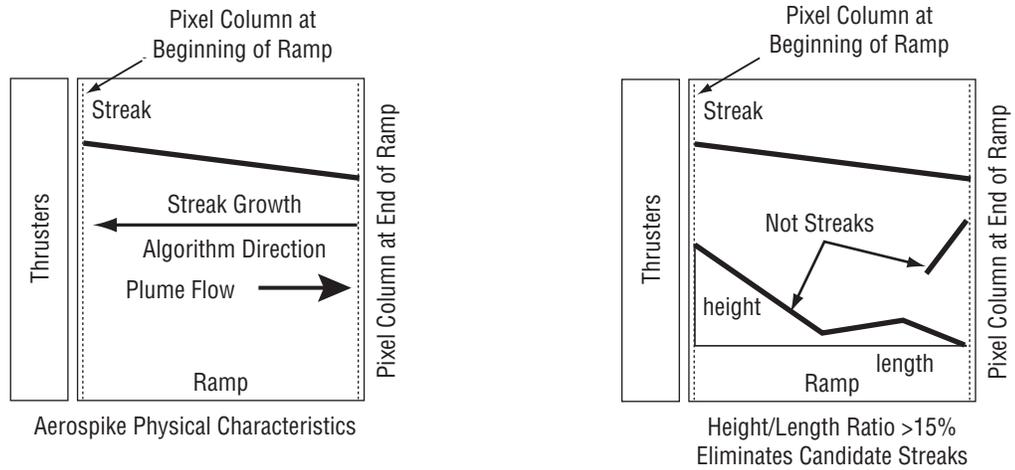
Figure 6. Streak confirmation.

The streak length and streak growth direction confirm candidate streaks (fig. 6):

1. Each thruster provides a lane for growth of a streak; i.e., a streak should not enter the plume of two thruster plumes. There are 10 thrusters on the aerospike panel and the number of pixels in a column covering a single plume area averages ≈ 110 . Therefore, no streak should grow in the column direction more than 11 pixels from the starting pixel column location.
2. The pixel distance from the end of the ramp to the beginning of the ramp near the thrusters averages 120 pixels, a growing-slope ratio of ≈ 10 percent.
3. A growing-slope ratio bound of ≈ 15 percent, evaluated as the streak is growing, serves to keep the streak growth reasonably within a plume. This check is initiated only after the streak has grown by 10 pixels.
4. If a growing path reaches the pixel column at the beginning of the ramp, this indicates a reportable streak was found.

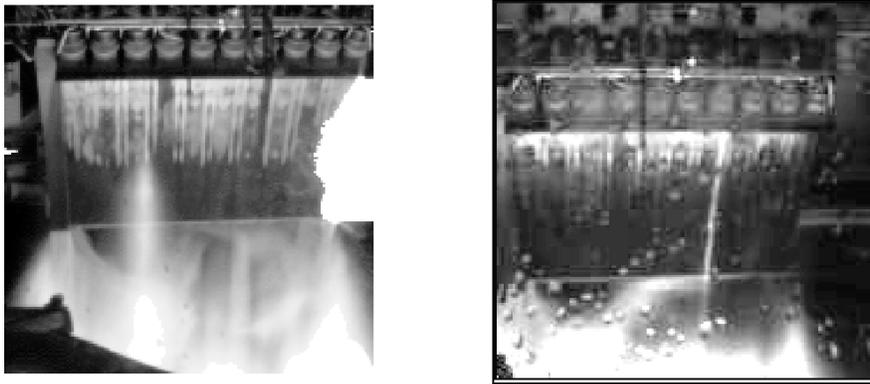
Figure 7. Aerospike ramp temperature-dependent lines and streak growth.

The ramp of the aerospike engine is cooled much like the nozzle bell of the SSME. Several temperature-dependent areas on the ramp produce light colored areas that often appear in the same intensity range and run in the same directions as streaks (fig. 7). The streak growth algorithm attempts to take this into account as it traverses the path of the suspected streak.

Note that true engine streaks are usually visible from the end of the ramp up to the thruster nozzle exit area. Because of the higher average intensity value of pixels in the nozzle exit area, the differences in intensity of streak pixels to pixels surrounding the streak in the thruster nozzle exit area are consequently a little less.

If an engine streak exists and a growth path reaches one of the temperature-dependent streak patterns of the ramp near the nozzle exit area, it is probable that the growth algorithm will complete the path and a streak will be reported, since the intensity of the streak and the temperature dependent area become very similar. Conversely, if a streak does not exist, it is entirely possible that a partial streak growth path matches with one of the temperature dependent high intensity areas and the streak growth algorithm will push forward to the beginning part of the ramp and report a streak.

The 80-percent value between the maximum and the average value for a pixel row midway between the dark end section of ramp area and lighter nozzle exit area portions of the ramp will exclude many false streaks that would grow along a ramp temperature induced intensity line since intersections with these lines are included in the average calculation. However, close-in to the thruster nozzle exit planes, nearly all streak candidates will finish their growth paths. Most incomplete growth paths are weeded out early and certainly before 90 percent of a complete streak path is final.

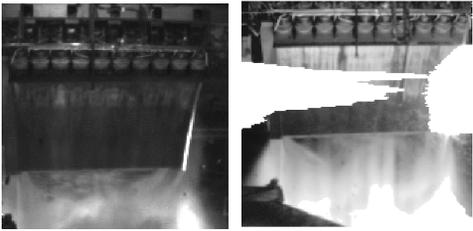
Category	Description	Examples
CCD Bloom	Maximum intensity region, derived from CCD pixel voltage overflow. All pixel values in this region have numeric value 255.

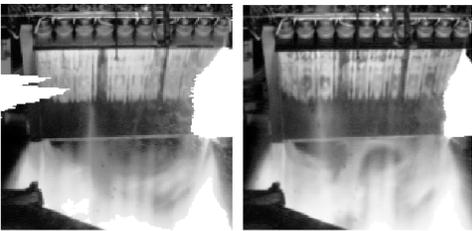
Light Intensity Linear Plume Anomaly	Very diffuse streak-type phenomenon. Boundary not well defined. Insufficient intensity to be considered a streak.

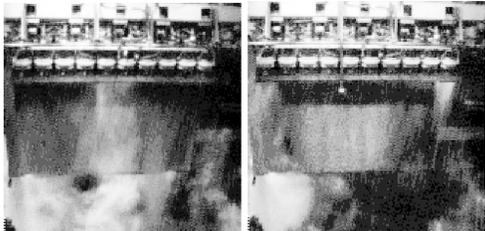
Startup Pop	Strong intensity linear phenomenon, extending from thruster nozzle exit plane to midramp area. Occurs during startup.

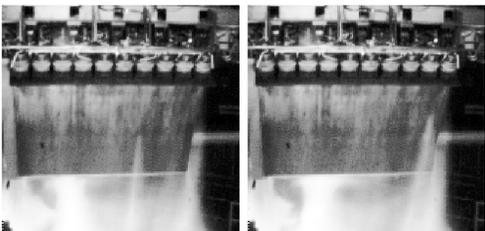
Debris Induced Streak	Linear plume phenomenon caused by debris hitting the plume. Starts from a position below the thruster nozzle exit planes.

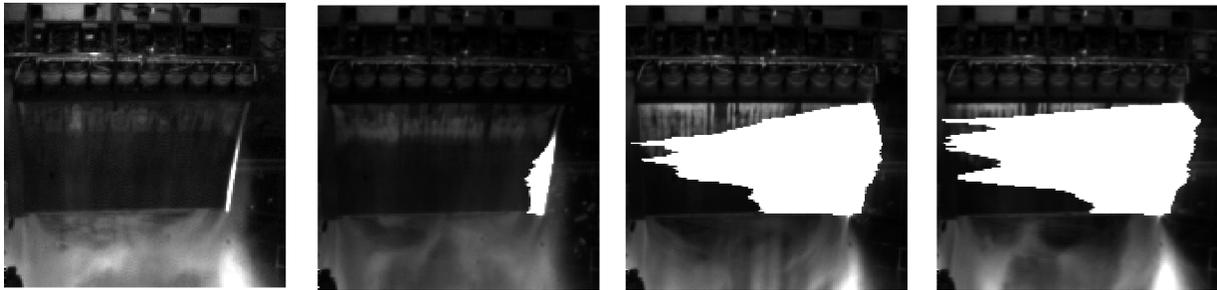
Figure 9. Growth of bloom during test A1X026.

Blooming on the HSO DALSA camera spills charge directionally along a column of pixels. On tests A1X024–A1X026, the charge spilling direction of the camera was directed onto the ramp area from the edge (fig. 9). To mitigate the effects of blooming on the HSO camera, the camera was turned 180 degrees. Since the bloom originated near the edge of the ramp, this reversal of charge spilling direction within the camera allowed the charge to drain away from the ramp area.

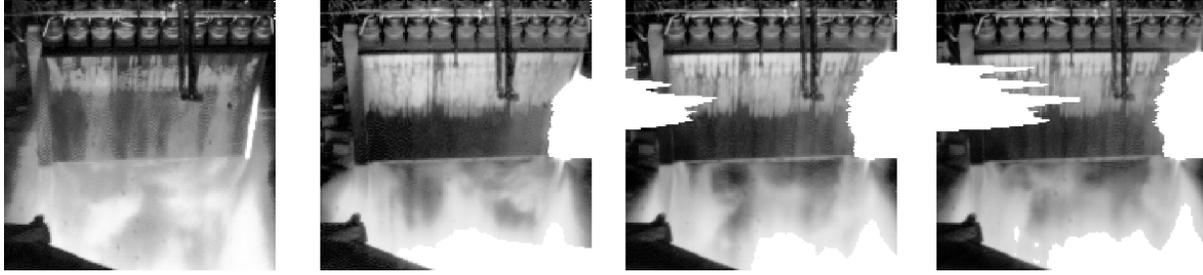
Figure 10. Growth of bloom during test A1X027.

Turning the DALSA camera 180 degrees in its mount partially mitigated the blooming problem. As shown in figure 10, the direction of blooming moved away from the origination area on the ramp toward the frame edge. Note the bloom direction travels in the opposite direction from that in figure 9. A wraparound effect, however, continued the bloom and made it reappear on the opposite side of the frame. At 100-percent power level, the bloomed area entered the ramp area from the side of the frame opposite the area where the bloom initiated and eventually touched the area where the bloom had initiated. Even at power levels <100 percent, it appeared the distance from the bloom initiation point to the frame edge was not sufficient to absorb enough energy to prevent the wraparound blooming effect.

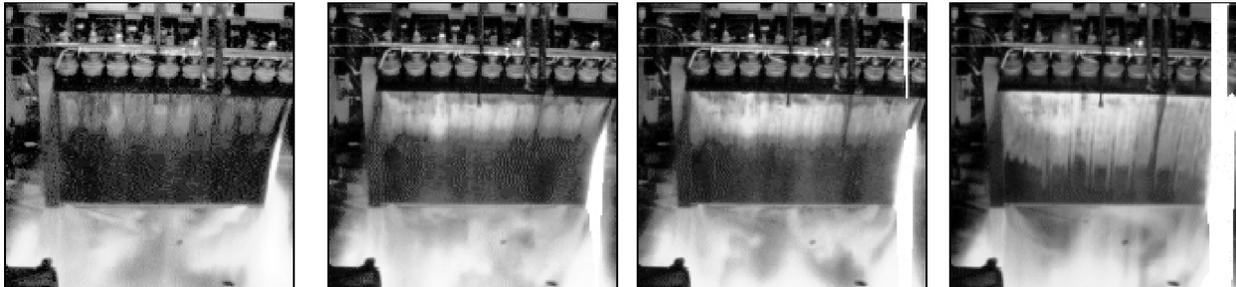
Figure 11. Growth of bloom during test A1X030.

Since the bloom originated in an area at the side of the ramp, turning the camera, so that the bloom proceeded parallel to the plume flow across the ramp, allowed the camera CCD to bloom, yet preserved much of the image for streak analysis. Figure 11 illustrates the growth of the bloom. Only the region directly below or above the glowing ablative layer is affected by the bloom, permitting streak analysis of most of the thruster exhaust plume area.

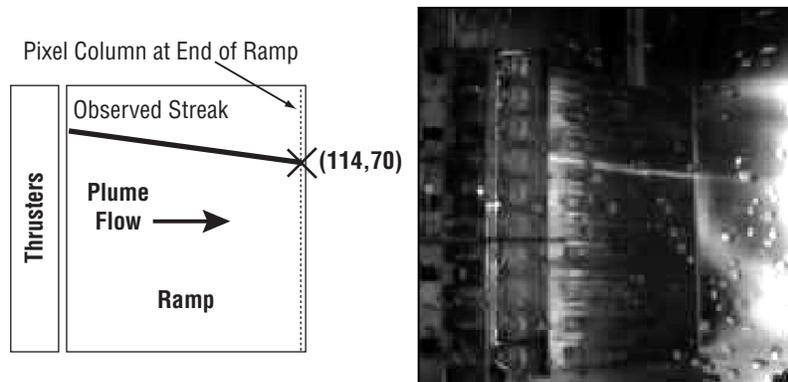
Figure 12. Streak detection: test A1X023/frame 3021.

Table 1 lists the frames where a streak was reported by the new streak detection algorithm. The older streak detection algorithm had failed to detect any streaks during this test. Also listed in table 1 are the 80-percent level intensity control value, the intensity value observed for the local maximum which was selected as the seed point for growing possible streak, and the location of the seed point for growing the streak path. Figure 12 illustrates the type of streak observed during test A1X023.

The streaks noted in test A1X023 are long and thin; they begin at the thruster exit plane and extend past the ramp. The boundaries of the streaks are well defined with intensity levels within the streaks much greater than the average intensity of the surrounding pixels.

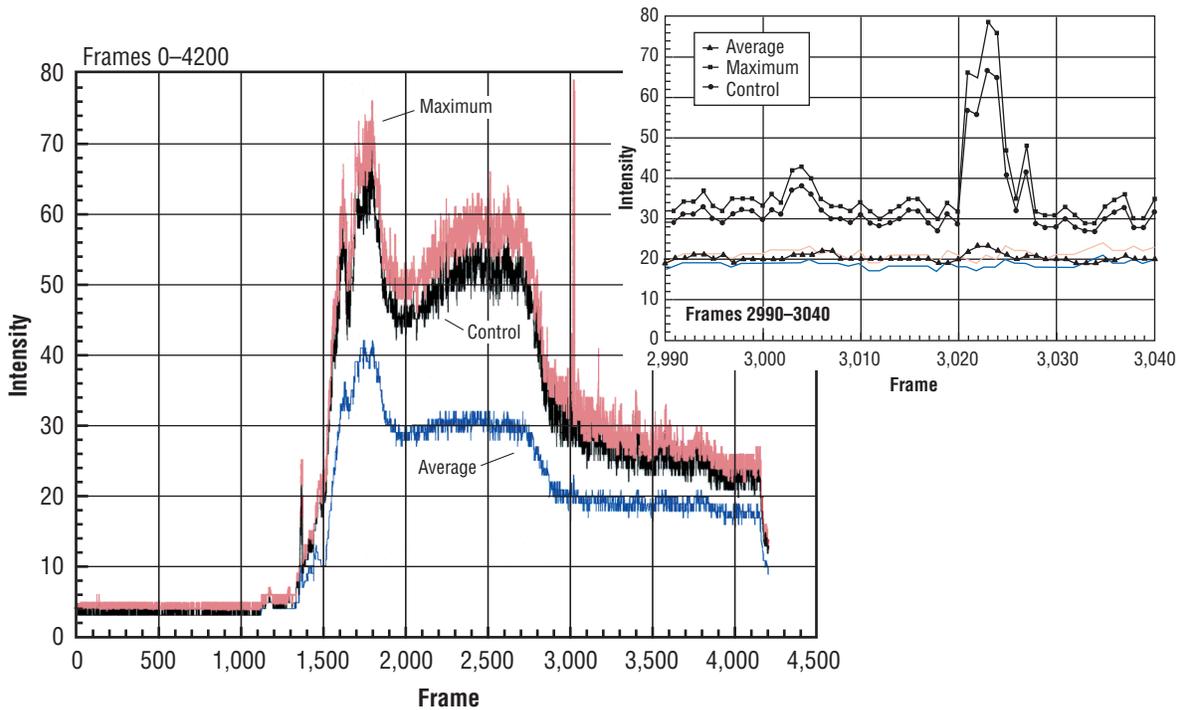
Figure 13. Intensity values used to determine a streak.

Figure 13 illustrates the operation of the streak detection algorithm. The three intensity values, the mean intensity of a column, the maximum intensity of the pixels in a column, and the control intensity used to determine a threshold value for local maxima selected as seed pixels, are shown in the figure from 0 to 4200 frames. A closeup of the region from frames 2990 to 3040 shows the pixels chosen as seed points and their relation to the control intensity.

Streaks are usually the brightest elements in a frame and are therefore related to the maximum intensity. The streak intensity value changes along the length of the streak path and a range of values must be allowed to admit enough values along the streak path for the streak path to reach the nozzle exit plane. The average intensity provides a floor for the intensity values along a column. The intensity of this floor changes with each frame. In figure 13, near frame 1750 the average intensity is ≈ 40 , whereas near frame 3250 the average intensity is ≈ 20 , indicating an overall average brightness change of ≈ 20 units between control columns in the two frames. The nonnormalized intensity value of ≈ 75 near frame 1750 does not indicate a streak when normalized with the high average column intensity, whereas the nonnormalized intensity value of 79 at frame 3024 normalized against the control intensity of ≈ 20 , indicates a possible streak.

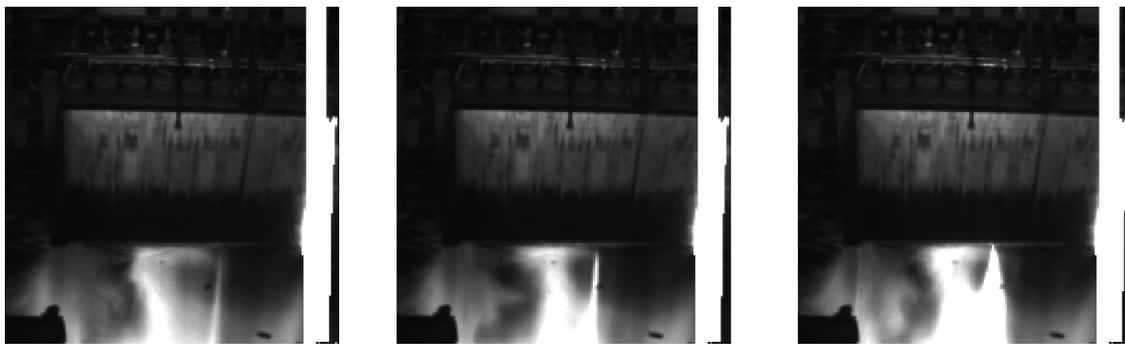
Figure 15. Plume streaks.

Prior to the flex seal burnthrough, a number of streaks were observed in the plumes below the ramp. Figure 15 illustrates several such streaks. The streaks occurred in the region where the burnthrough was noted.

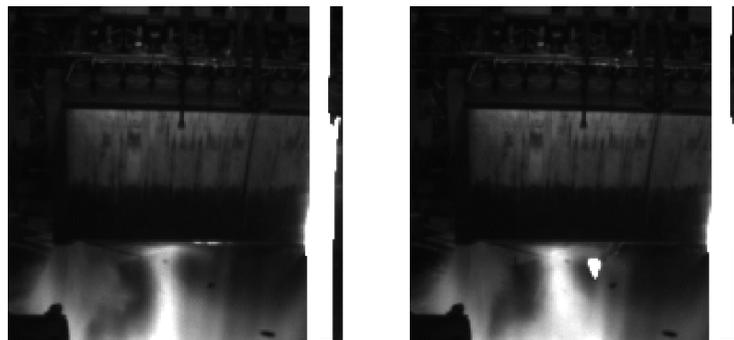
A glowing area appeared at the edge of the ramp, shown in figure 16, in the region of the burnthrough, well before the thermal protective flex seal material became evident as it dropped into the plume.
