NASA Technical Paper 3583

Impact Damage Resistance of Carbon/Epoxy Composite Tubes for the DC-XA Liquid Hydrogen Feedline

A.T. Nettles

September 1995

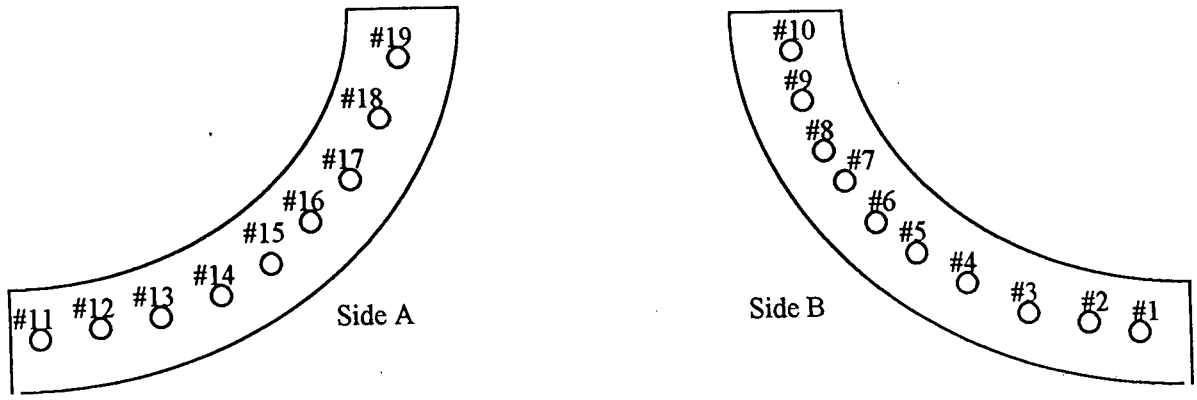
Figure 3. Location of impact sites for sharp impacts.

The tube was impacted 19 times at the sites shown in figure 3. Since the damage was highly localized, this large number of hits on one section of tubing was possible.

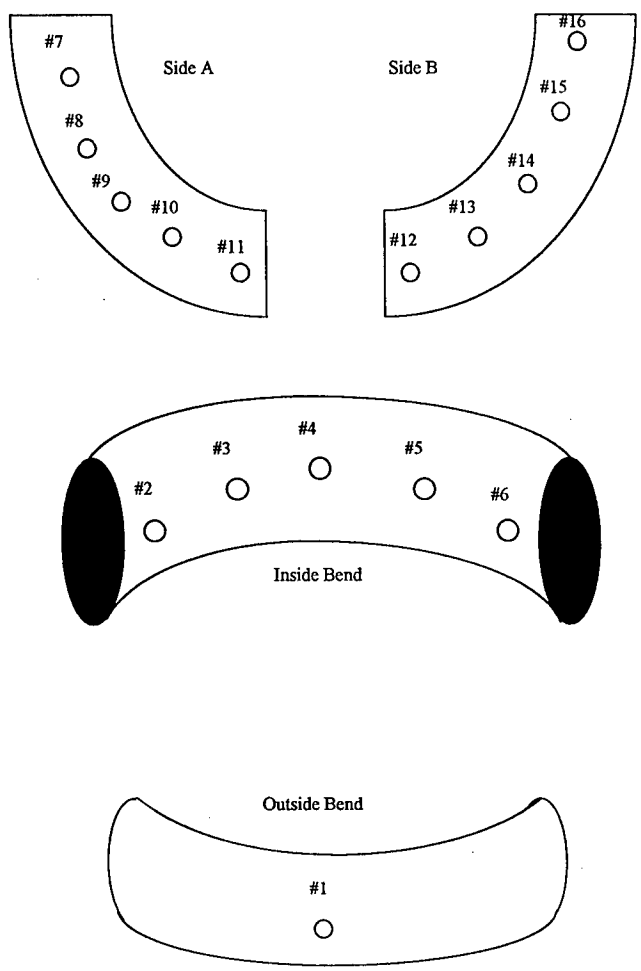
Figure 4. Impact sites for blunt impacts.

A second section of elbow tubing was impact tested using a 0.5-inch diameter semispherically ended rod that was considered a "blunt" type impact compared to the sharpened bolts and conical striker described in the previous section. A total of 16 impacts were conducted on this section of elbow as depicted in figure 4.

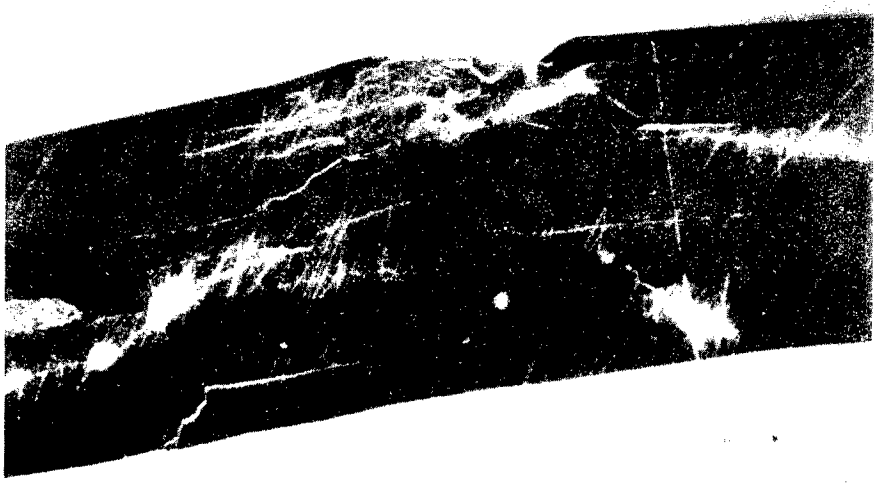
From the cross section of hit No. 7, it can be seen that no fiber breakage is present, but extensive matrix cracking exists. This was found to be typical of all of the impacts except Nos. 1, 2, and 3, which demonstrated obvious fiber breakage visible from the surface. The majority of the lengths of these cracks run between plies of carbon/epoxy as is typical of impact delamination damage. The leak paths form when these lines of delamination are joined by transverse cracks that bridge between layers. Some of these cracks can be seen on the photomicrograph of hit No. 7. Since the entire volume of impact damage cannot be represented by a cross-sectional photograph, a complete leak path may not be visible on any one plane perpendicular to the specimen. Thus, the density of cracks on the plane in the photomicrograph must be used to assess the likelihood of a leak path forming through the entire tube wall thickness. For example, the cross-sectional photograph of hit

No. 8 seems quite similar to that of hit No. 7, yet No. 7 leaked while No. 8 did not. These two photographs represent the borderline impact level at which leakage begins to occur.

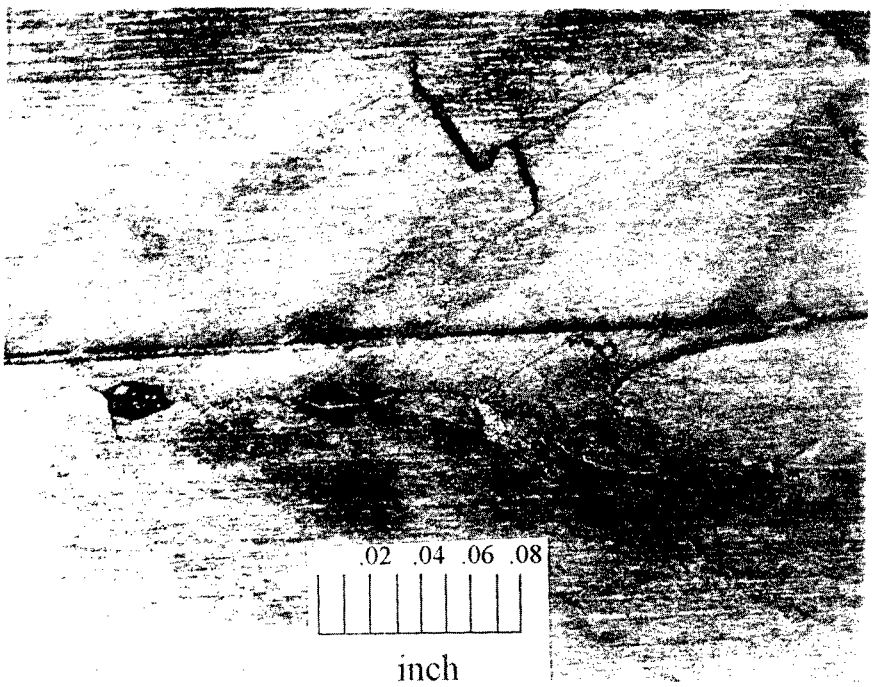
Hit No. 1

1. Surface Damage. Surface photomicrographs of the damage that caused leaks are given in appendix D. All of the photographs show matrix gel coat cracking in the region near the impact site with no localized damage present. This is due to the large diameter striker being used, which helps

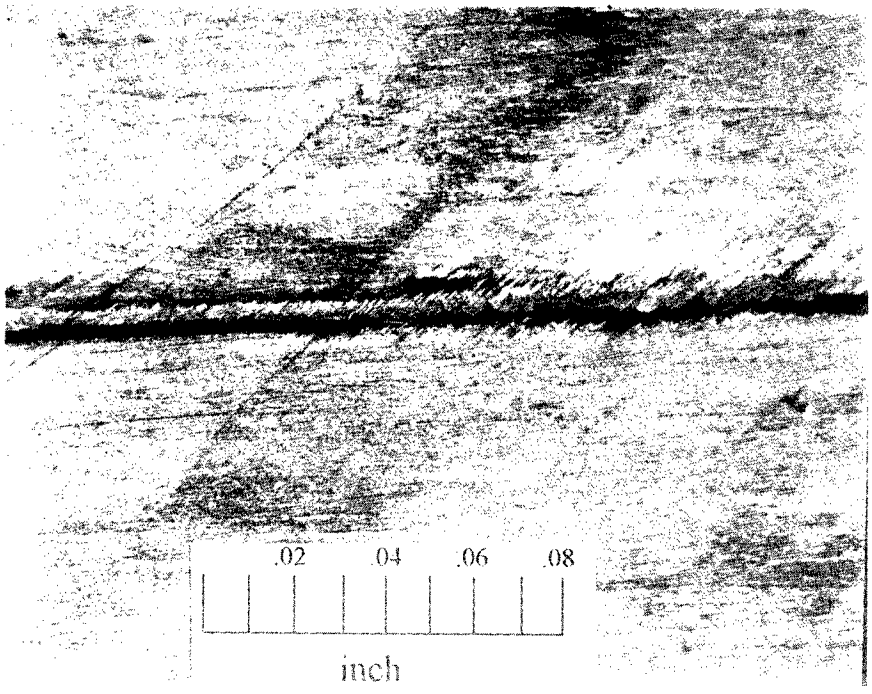
Hit No. 4

to spread the impact energy over a larger area, reducing localized damage. Note that on hits No. 4 and 6, the cracking was contained within the seam of the gel coat caused by the outer clamshell mold used in the processing of the part. These areas are resin rich, and the cracks can propagate much more easily in these areas than in those outside the seam which contain fibers closer to the surface. This indicates that impacts that occur on the "seam" of the tube may be much more difficult to visually inspect, thus care must be taken for these impacts.

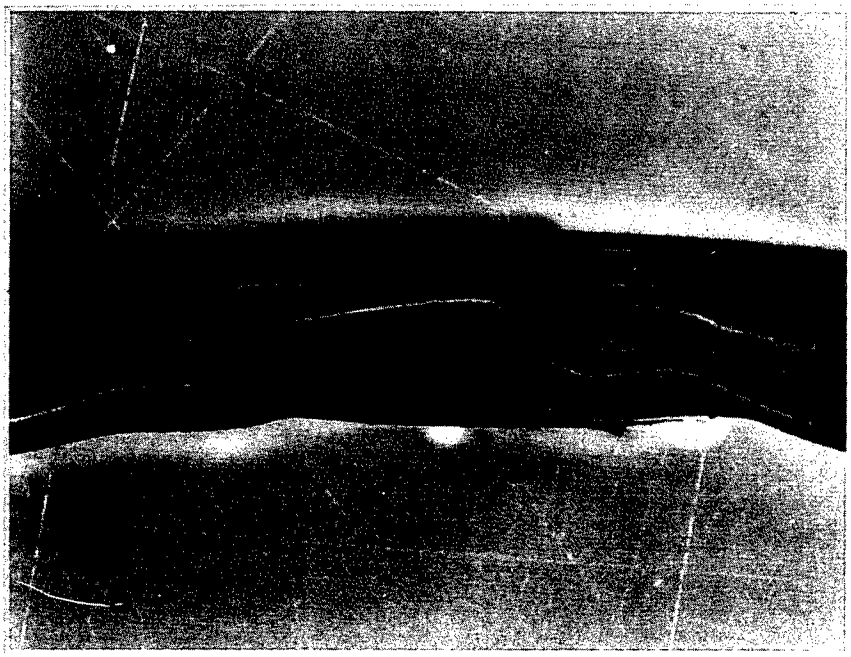
2. Cross-Sectional Examination. Cross-sectional photomicrographs of the impacted areas that caused leaks are given in appendix E. Extensive delaminations and matrix cracking are evident on specimens No. 1 and 2 as might have been expected due to the high leak rates observed. Specimens No. 4 and 6, which had surface damage confined to the "seam" area of the tube, show typical delaminations and matrix cracking, indicating that subsurface damage is not effected by the visible damage being restricted to the "seam" area. Specimen No. 15 shows the typical conical type damage mentioned in the previous section on sharp impacts.
