NASA Reference Publication 1390

Spacecraft System Failures and Anomalies Attributed to the Natural Space Environment

K.L. Bedingfield, R.D. Leach, and M.B. Alexander, Editor

August 1996

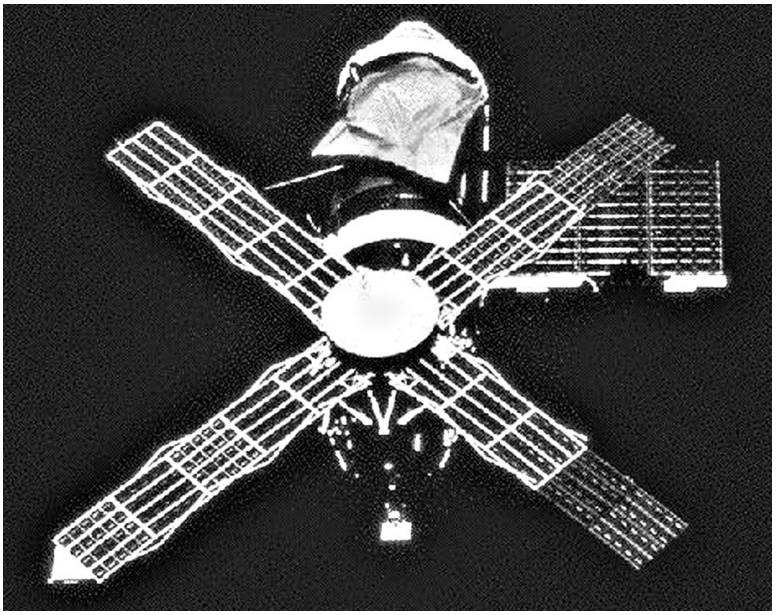
Figure 4. *Skylab*.

On July 11, 1979, *Skylab* (fig. 4) prematurely reentered the Earth's atmosphere. This orbiting laboratory, the first of its kind, experienced the density effects of the neutral thermosphere. As atmospheric drag increased, the spacecraft reached the point at which it could no longer stay in orbit, and before a rescue mission could be launched, it fell to Earth.[4]

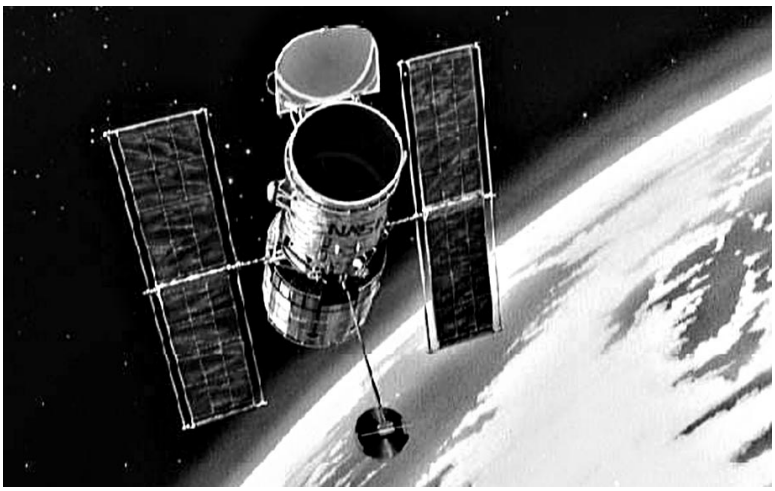
Figure 7. HST.

Before the December 1993 HST service mission, the solar arrays vibrated severely each time the observatory emerged from shade into sunlight. Active vibration cancellation using the onboard gyros was implemented before the service mission to minimize the problem. Thermal expansion of the support poles (also called bistems) was blamed for the vibrations, which interfered with deep-space observations. The new arrays installed during the service mission had sleeves over the bistems to provide jitter-free imagery[7] (fig. 7).

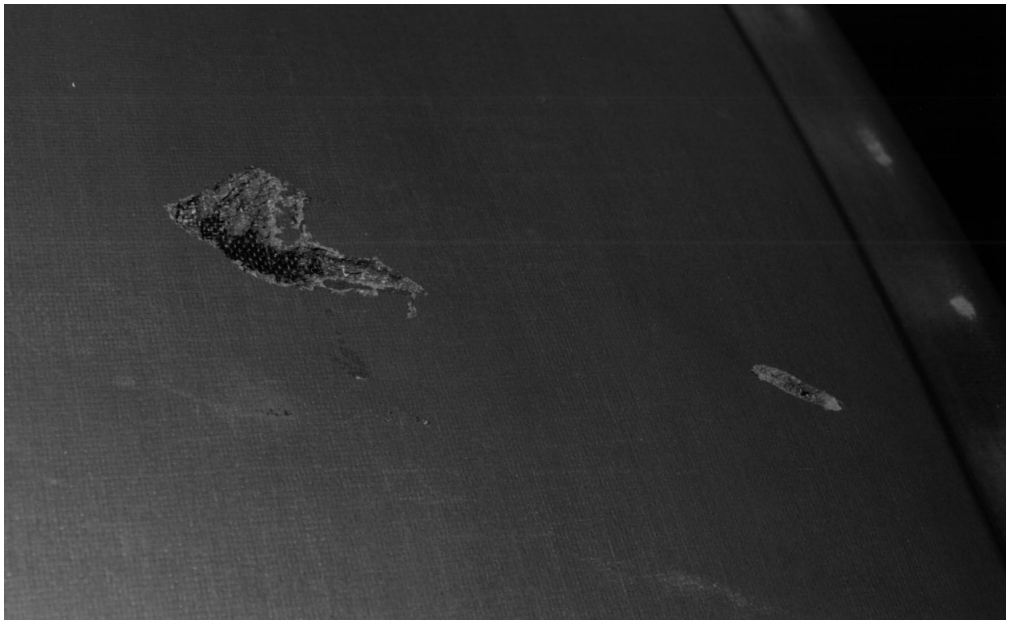
Figure 13. Orbiter *Atlantis* (STS-45) right wing leading edge gouges.

On Space Shuttle mission STS-45, launched March 24, 1992, the orbiter *Atlantis* suffered two gouges, (1.9 by 1.6 in. and 0.4 by 1 in.), on the upper portion of the right wing leading edge (fig. 13). The most probable cause was a low-velocity (relative to the spacecraft) debris impact on orbit or during reentry. However, Johnson Space Center (JSC) engineering has not ruled out prelaunch or ascent debris as the cause of the damage. This particular event raised concern about the consequences of a higher energy impact to the integrity of the spacecraft.[11]
