NASA/TM—1998–208539

Final Report on Life Testing of the Vapor Compression Distillation/Urine Processing Assembly (VCD/UPA) at the Marshall Space Flight Center (1993 to 1997)

P. Wieland, C. Hutchens, and D. Long
Marshall Space Flight Center, Marshall Space Flight Center, Alabama

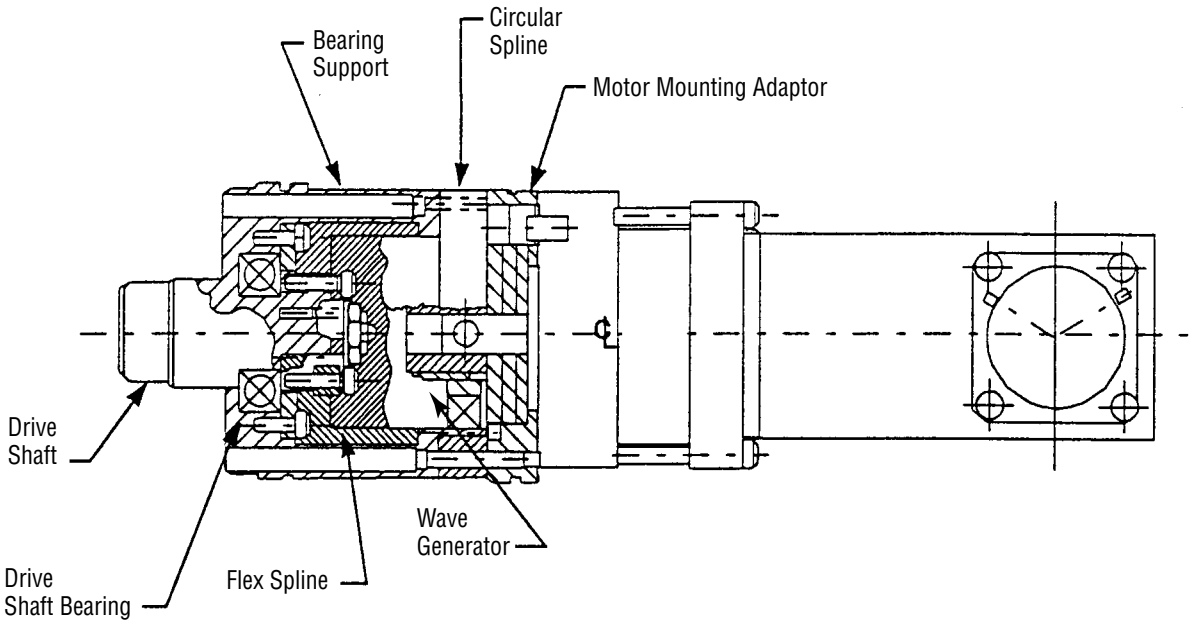
Figure 10. Harmonic Drive.

The first anomaly occurred during checkout testing of the VCD–5A at LSI when the flex spline failed in a gear speed reduction mechanism in the Harmonic Drive for the fluids pump (see fig. 10). At that time the drive had operated for about 400 hr. The failed part was analyzed at MSFC, however, a definite cause of the failure could not be determined because the failure surfaces were smeared due to the assembly operating after the component had sheared. (See the third anomaly for more information.) The drive was replaced with a new one of the same design. Previously the Harmonic Drives had operated for much longer without failure, as shown in table 2.

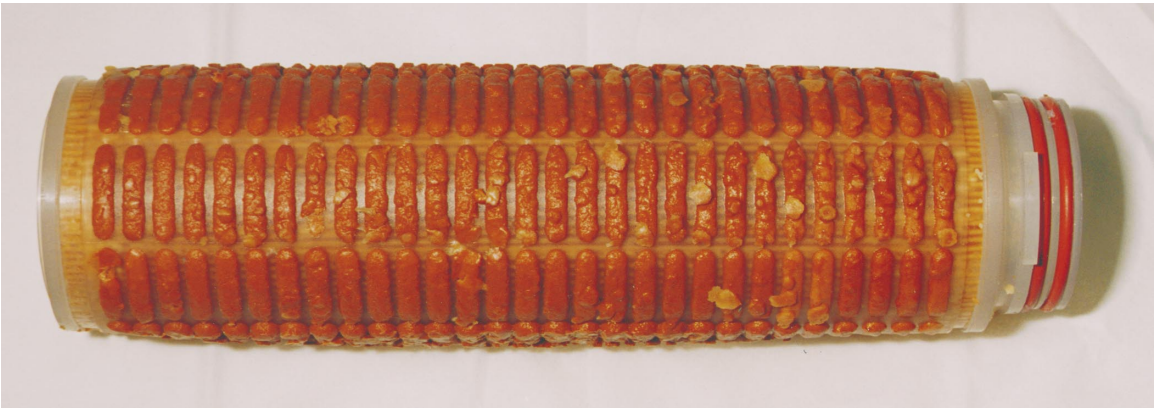
Figure 18. VCD–5 10 μm pore size filter used during WRT Stage 10.

4.4.2.1.4 Calculation of the Percentage of Solids in the RFTA. The criteria for determining when to clean the recycle tank and replace the filter was initially based on when the VCD software controller indicated it was time for replacing the filter, calculated by the amount of wastewater processed. As the solids concentration increases the filter becomes coated, as shown in figure 18. The amount of

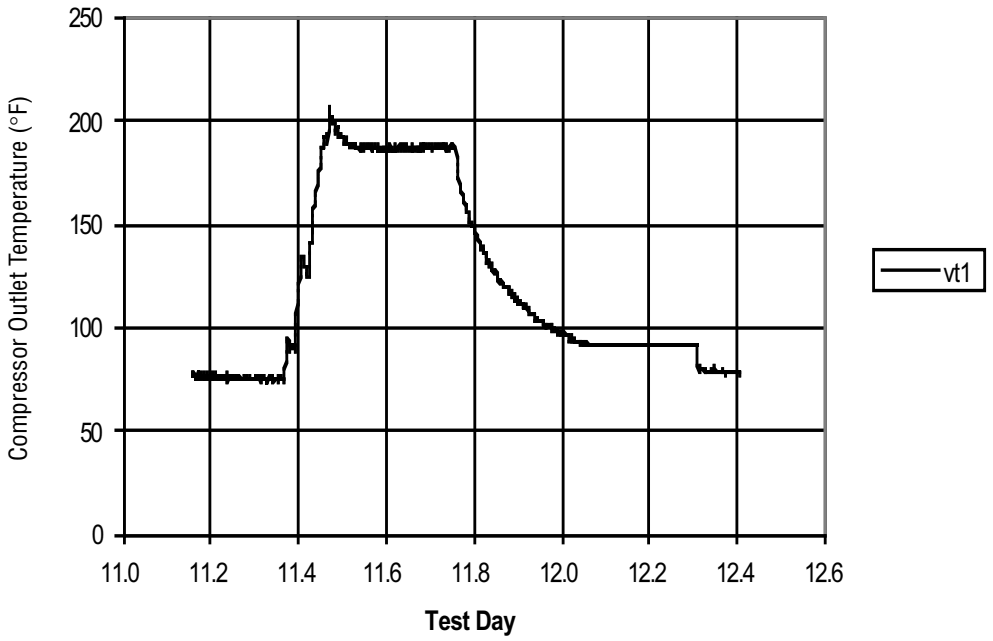
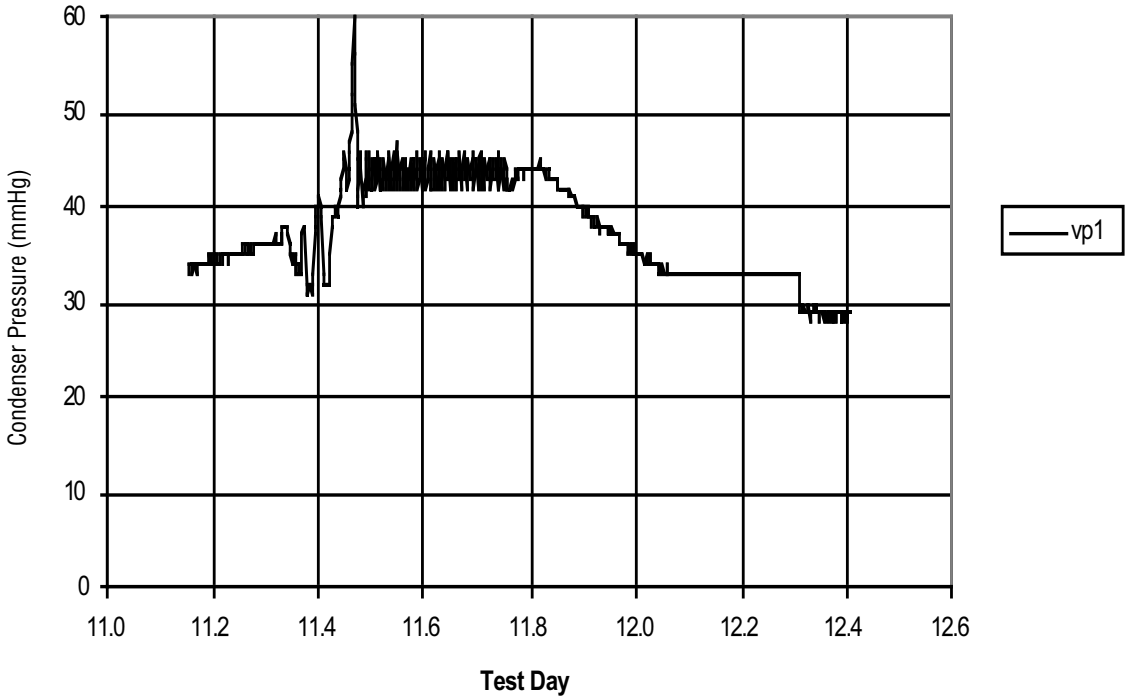
4.4.2.1.5 High Temperatures and Pressures in the Still. As shown in figures 19 and 20, at the beginning of a processing cycle, high temperatures and pressures occurred in the still during the first 40 min before coming down to the desired ranges. The temperature was measured at the outlet of the compressor (vt1) and indicated the temperature close to the gears. The temperature spiked above the alarm setpoint of 93 °C (200 °F) due to the excessive load on the compressor and/or inadequate cooling of the gears. The pressure was measured in the condenser (vp1) and reached about 60 mmHg. These same conditions occurred during previous testing (see the Stage 9 report [8]) and were attributed to air in the wastewater tank collecting at the top of the tank, where the outlet is located, and being injected into the still (in microgravity the air would likely be more evenly distributed throughout the liquid). Therefore, until liquid was injected into the still, no evaporative cooling would occur. The condition of the compressor gears was also found to be a factor. After test day 37, when the Vespel® gear was replaced, the temperature and pressure spikes were reduced considerably, to within the desired ranges (as shown in figures 21 and 22). After test day 65, when a sample port (number 19) was added to the top of the feed tank, the temperatures and pressures at startup were reduced further (as shown in figures 23 and 24). In the process of collecting samples of the feed mixture, at the beginning of each processing cycle, the air was purged from the supply line. The transition time required to reach normal operating conditions was reduced from over 3 hr to under 2 hr, due to replacing the Vespel® gear and purging air prior to a processing run.

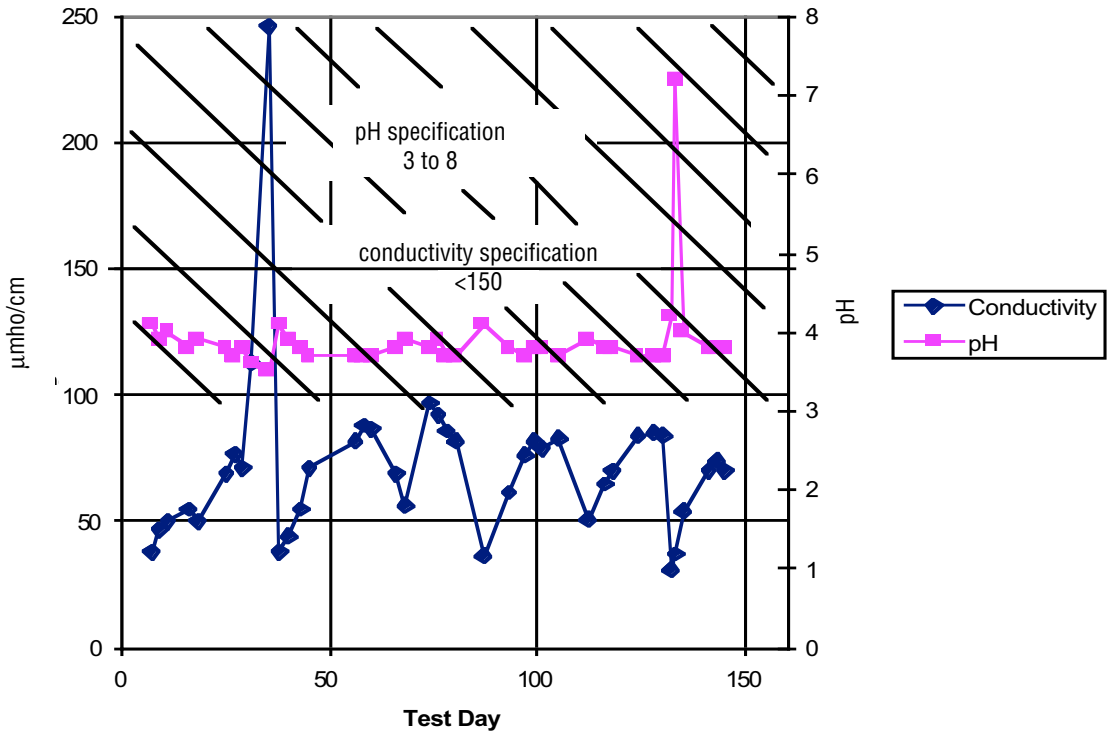
Figure 26. VCD–5 product water conductivity and pH.

High conductivity was not detected later in a cycle and samples of the product water were well within specification (with one exception on test day 35, as shown in figure 26 which also shows the pH of the product water samples). One effect would be a reduction of the production rate, and this may have contributed to having a lower average rate than for Stage 9. The primary cause of this condition was later found to be due to leakage of brine into the fluid pump housing (see section 4.4.1.1).

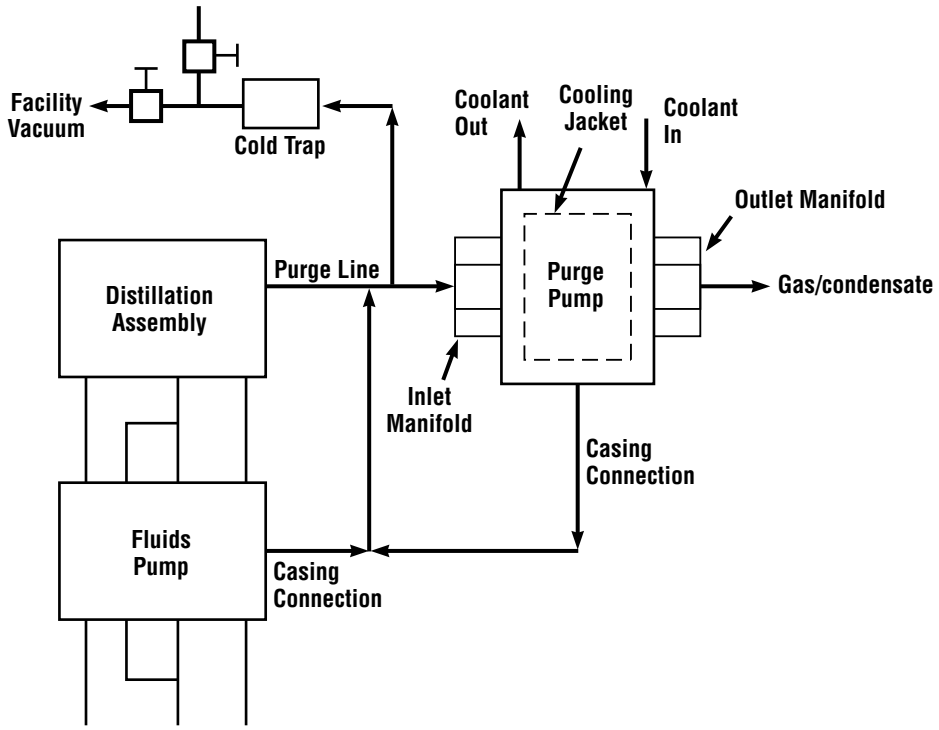
Figure 35. Facility vacuum connection to the purge and fluids pumps.

Also, moisture was still found in the moisture trap in the facility vacuum line which indicated leakage of ambient air into the pump housing or through the pump tubing.

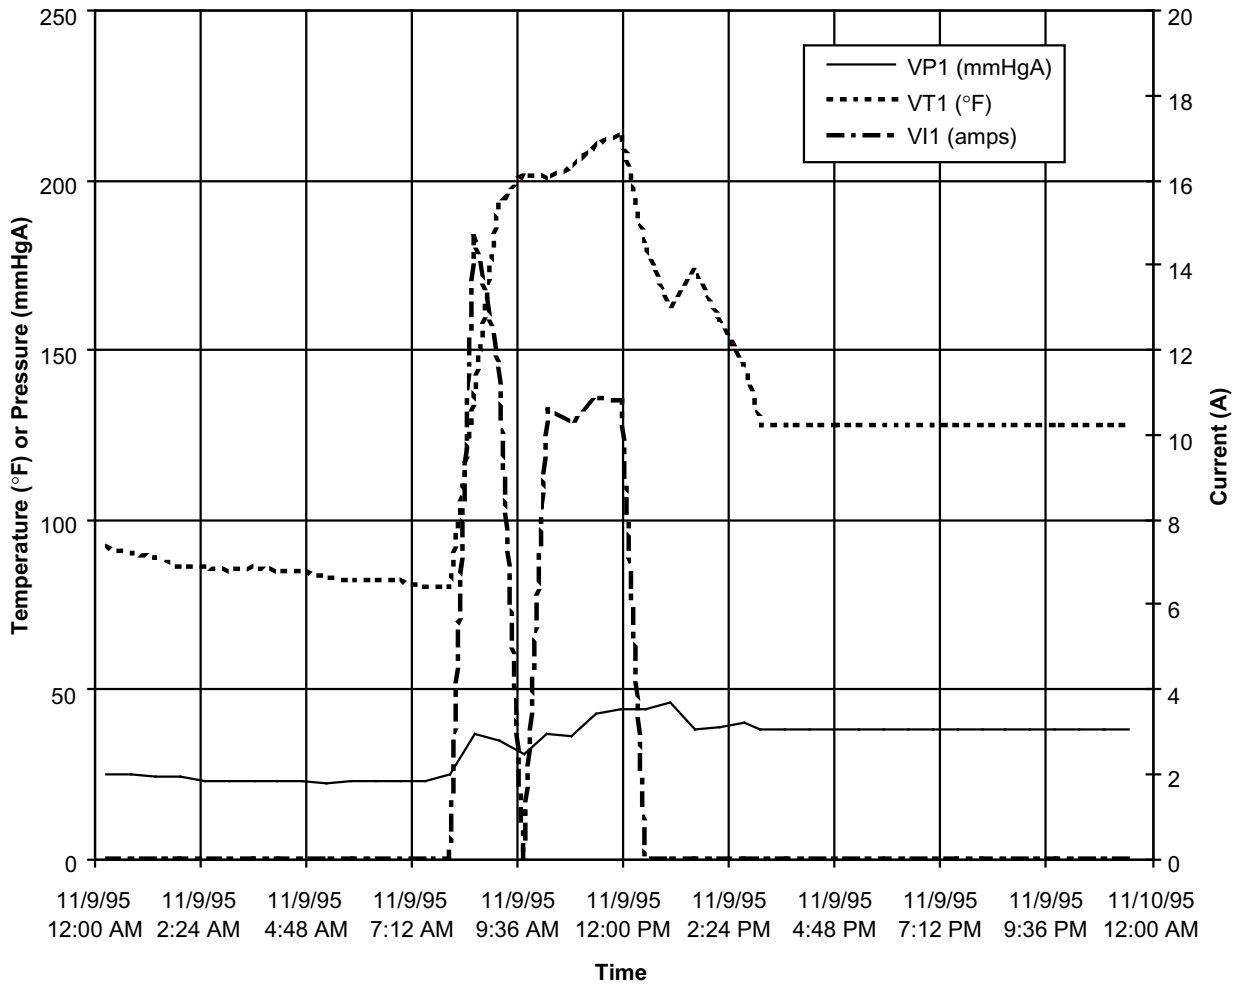
Figure 36. VCD–5A current, temperature, and pressure profiles in November 1995.

A field service was arranged to correct the problems. Due to a government furlough, the field service was postponed until January 16, 1996. Prior to disassembly, a pressure check was performed that showed no leakage into the still. The VCD–5A was then transitioned to *normal* mode. A loud noise came from the VCD–5A and the compressor motor drew excessive current (17A). The VCD–5A was switched off and disassembled.

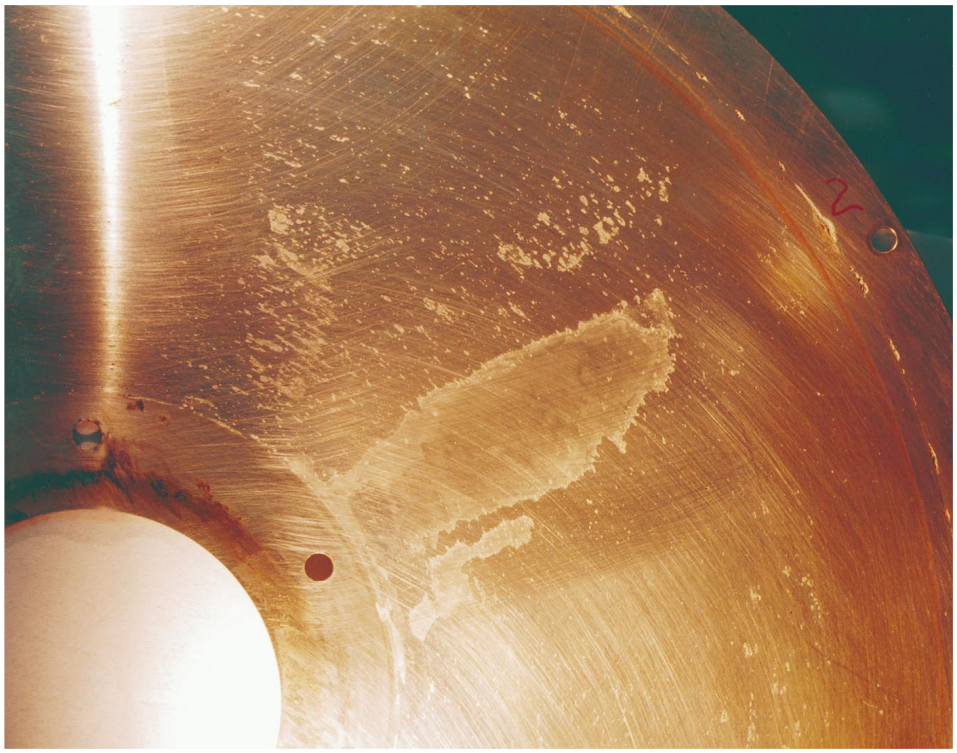
- An O-ring seal was missing between the condenser end plate and the drum. However, there was no indication of liquid leakage, so the metal-to-metal contact apparently provided an adequate seal.
- Some slight corrosion was evident between the condenser end plate and the drum spokes, as shown in figures 37 and 38.

Figure 37. VCD–5A end plate showing light corrosion.

Figure 38. VCD–5A distillation drum spokes showing light corrosion.

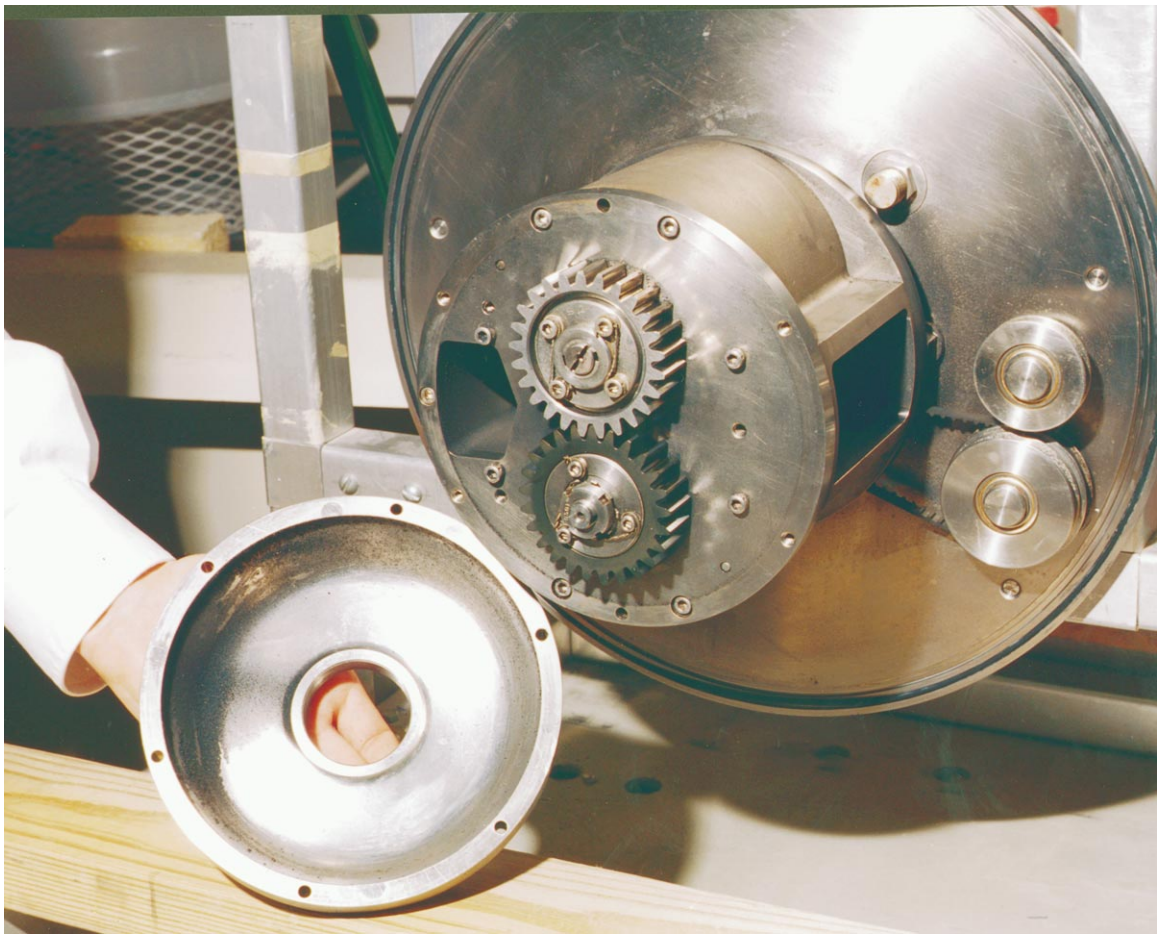
- The compressor gears showed wear, with a gap of 0.330 to 0.419 mm (0.013 to 0.0165 in.) rather than the desired 0.152 mm (0.006 in.), but there were no chips or missing teeth. There was a coating of Vespel® lubricant dust on components of the compressor, as shown in figure 40. Examination under a microscope also showed metallic particles on the Vespel® gear. The recorded time of use for this set of gears is 4,831 hr of cyclic operation. The established life limit for these gears is 12,000 hr of continuous operation. The condition of the gears indicated that they had reached the end of their useful life.

Figure 40. VCD–5A disassembly showing old compressor gears.

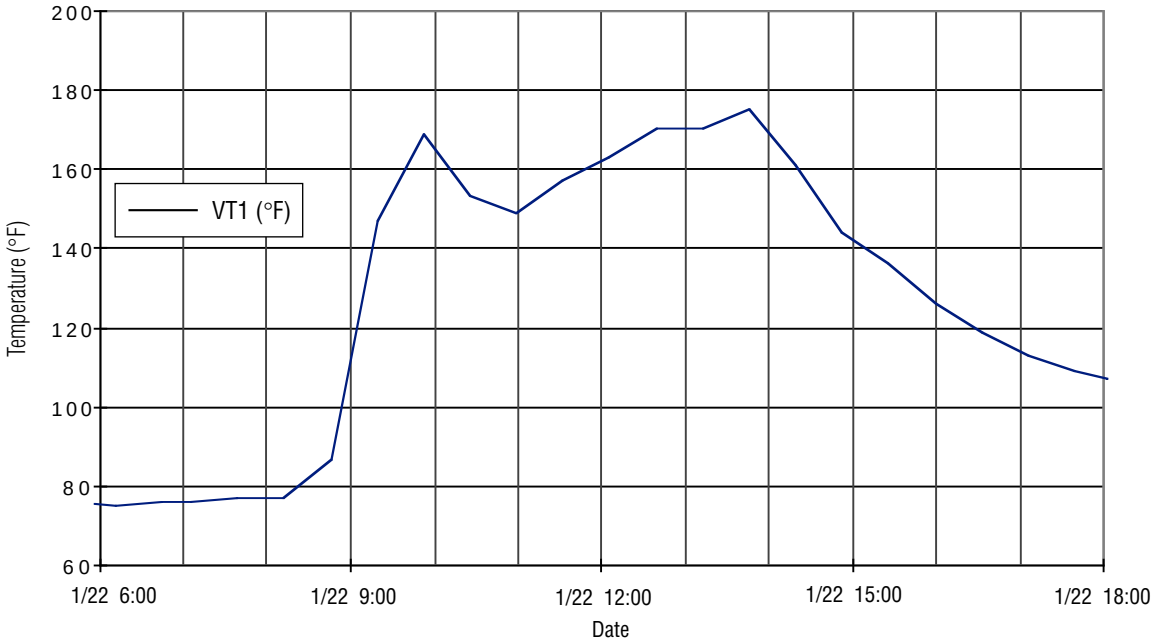
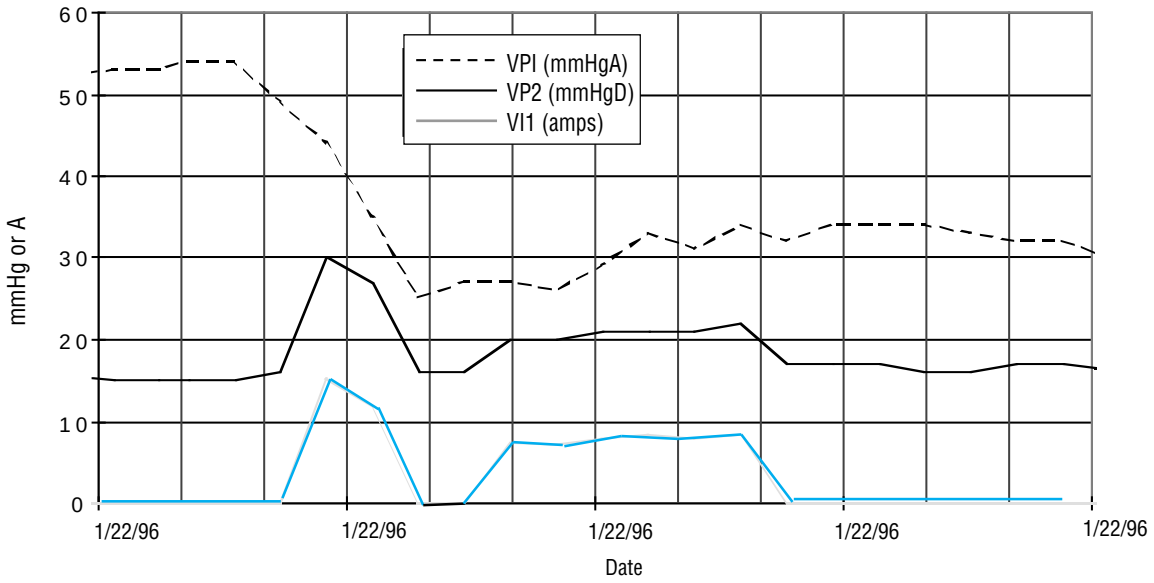
However, after a period of no operation (such as over a weekend), the unusual behavior was repeated and shutdown occurred about one hour after startup on the following Monday. When the unit was restarted, again, it operated normally and on subsequent days during the week operation was normal. On Monday of test week 159, January 22, 1996, the condenser pressure increased to 54 mmHg and the VCD–5A required additional power to bring the pressure down to normal operating conditions (32 to 45 mmHg). I1 started at 15A and after 15 min dropped to 12.6 A. I1 then jumped to 18A after 45 min in normal and an alarm caused a shutdown. The VCD–5A was immediately restarted and ran nominally with I1 remaining around 8A. The VCD–5A ran nominally for the remainder of the week, as shown in figures 41 and 42.

Figure 41. VCD–5A compressor temperature (T1) after repairs in January 1996.

Figure 42. VCD–5A compressor motor current (I1), condenser pressure (P1), and compressor differential pressure (P2) after repairs in January 1996.
