High-Speed Observer: Automated Streak Detection in SSME Plumes

TECHNICAL MEMORANDUM

HIGH-SPEED OBSERVER: AUTOMATED STREAK DETECTION IN SSME PLUMES

1. AGENCY USE ONLY (Leave Blank)	2. REPORT DATE February 2001	3. REPORT TYPE AND DATES COVERED Technical Memorandum		
4. TITLE AND SUBTITLE High-Speed Observer: Automated Streak Detection in SSME Plumes			5. FUNDING NUMBERS

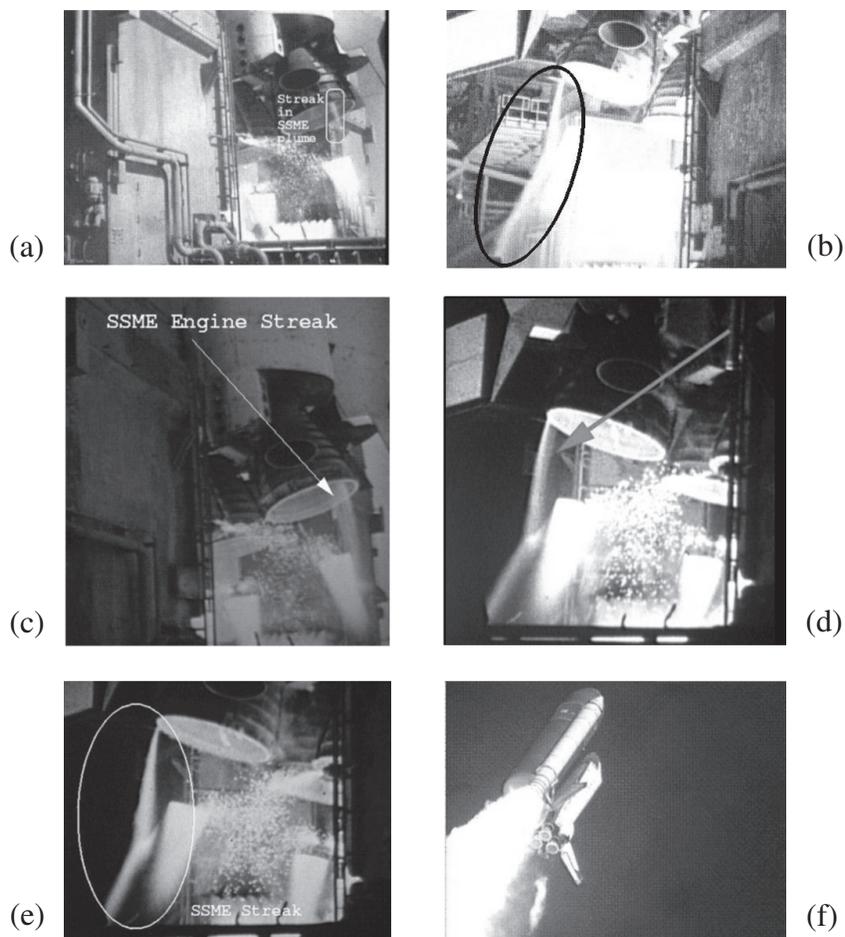
Streaks in SSME plumes are typically generated during combustion of contaminant products in the fuel or oxidizer, as from significant erosion of metal. These streaks originate from within the combustion chamber and are visible as the gas is ejected from the nozzle exit plane. Typical engine streaks are shown in figure 1(a)–(e).

Debris falling into the plumes also produces visible streaks. Streaks associated with debris are generally short in duration and are initiated at the site of debris impact with the plume boundary. Such streaks are rarely positioned near the exit plane. A large debris-induced streak occurred on mission STS–58, as shown in figure 1(f).

Figure 1(a)–(f). SSME plume streaks.

On January 25, 1996, at SSC, SSME test 901–853 of the block II development engine 0523 (ref. 1) was terminated at 553 sec into a 754-sec test. Posttest analysis of images recorded by high-speed video camera revealed over 400 plume events during the test. Thirty-one of these plume events produced streaks that encompassed the entire circumference of the plume. The first such significant plume event was a bright white flash at T+130.284 sec. Termination of the test was called by a human observer due to continuous abnormal plume coloration that indicated equipment malfunction. Earlier termination of the test might have saved components that were consumed by the test and could have enabled evaluators to better analyze the failure mechanisms.

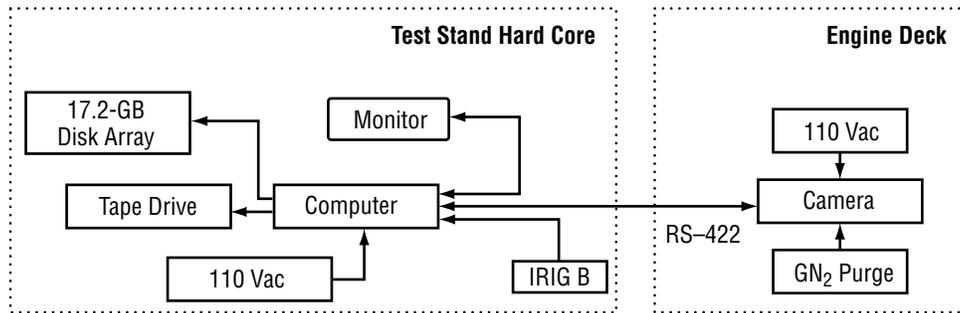
The HSO system, depicted in figure 2, uses a 200-fps, 256×256 pixel, DALSA[®] charge-coupled device (CCD) array camera to generate 8-bit, gray-scale digital images. This camera is mounted inside a PELCO[®] EHX6-16 explosion-proof housing for protection against the rugged environment experienced during testing. The HSO camera position at SSC is shown in figure 3. The ideal camera position on the test stand is on or slightly above a plane, horizontal with the midpoint between the nozzle exit plane and the Mach disc. This position provides a single line of reference at the nozzle exit plane for the region of interest.

Figure 2. HSO system.

The current HSO system uses a Dual Pentium® Pro 200-MHz computer running Microsoft Windows® NT with a BitFlow, Inc. Road Runner frame capture board to process images in real time. Each image frame is encoded with interrange instrumentation group (IRIG) timing and recorded on a 17.2-gigabyte (GB) redundant array of inexpensive disks disk system. After testing, images are stored on an 8-mm Exabyte® tape and shipped to Marshall Space Flight Center for posttest analyses.

The f -stop of the camera is set so that the high-intensity values of the image are in the midrange of the camera CCD response band. Although this high f -stop setting makes the images of the normal plumes in HSO imagery appear dark, the bright Mach disc and engine streaks are easily detected.

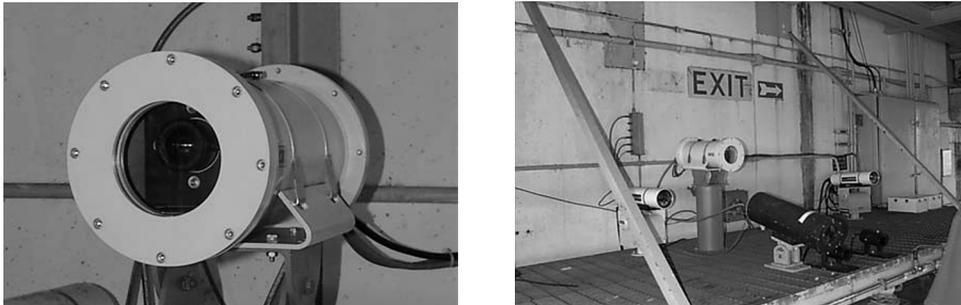
Figure 3. HSO installation at SSC.

The fourth step was the installation of the HSO system at SSC. During the week of June 23, 1997, the HSO hardware was installed into the A1 test stand. The high-speed digital camera was mounted on level four to view the SSME plume. The image processing unit was installed inside the hard core on level four. A remote-controlled computer was installed in the A-Side Test Control Center and the fiber optic communication link was established between the remote-controlled computer and the image processing unit. After a systems check was performed to verify that the hardware was functioning, the HSO began recording data during a series of SSME tests on the A1 test stand the week of July 7, 1997. Over 25 SSME tests have been monitored. Example runs from the actual recovered test image data recorded by the HSO system are included in section 3.

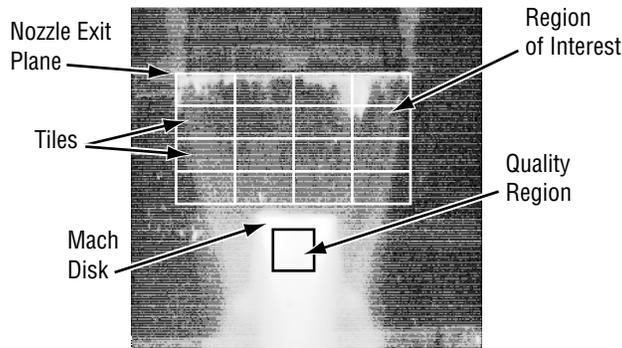
Image data validation consists of checking a quality region for a valid data signal and an obscured field of view as shown in figure 6. The quality region currently employed by the HSO system is a small, presently 5×5 pixel, fixed array acting as a reference point for validation of the image. Since the intensity of the Mach disc is approximately the same as that of a streak, the quality region was selected in the Mach disc. The average intensity value of the quality region is called the quality region value. A valid data signal indicates that the hardware is functional, determined by checking for nonzero data in the quality region.

An obscured field of view is detected by comparing the quality region value against an intensity threshold value, β . The value selected for β is below the average intensity value for the quality region and above the average intensity of the region of interest. A quality region value lower than β indicates that the region of interest may be obscured. This may occur when vapors pass between the camera and the plume flowfield. When this condition is observed, a flag is set in the data stream from the expert system, indicating that data are unreliable.

Figure 6. HSO image elements.

Plume streak detection utilizes a system based on a region of interest. The region of interest is a rectangular area extending from the nozzle exit plane to the Mach disc and bound by the width of the plume. This area, shown in figure 6, is divided into equal-sized, rectangular groups of pixels called tiles, figure 7(a). The number of pixels per tile varies with the size of the region of interest. In the current configuration, each tile is 32×32 pixels.

Pixel intensity in each tile is represented by an unsigned integer value from 0 to 255 (0 = black and 255 = white). A tile sum is computed by summing pixel intensity values over all pixels in a tile. If the summation is greater than a threshold value, the tile is said to be out of family and given a value of “1,” otherwise, the tile value is “0.” The tile threshold value is calculated using β multiplied by the number of pixels in the tile. Assigning a smaller value to β may include more reportable events and conversely assigning a larger value to β excludes reportable events.

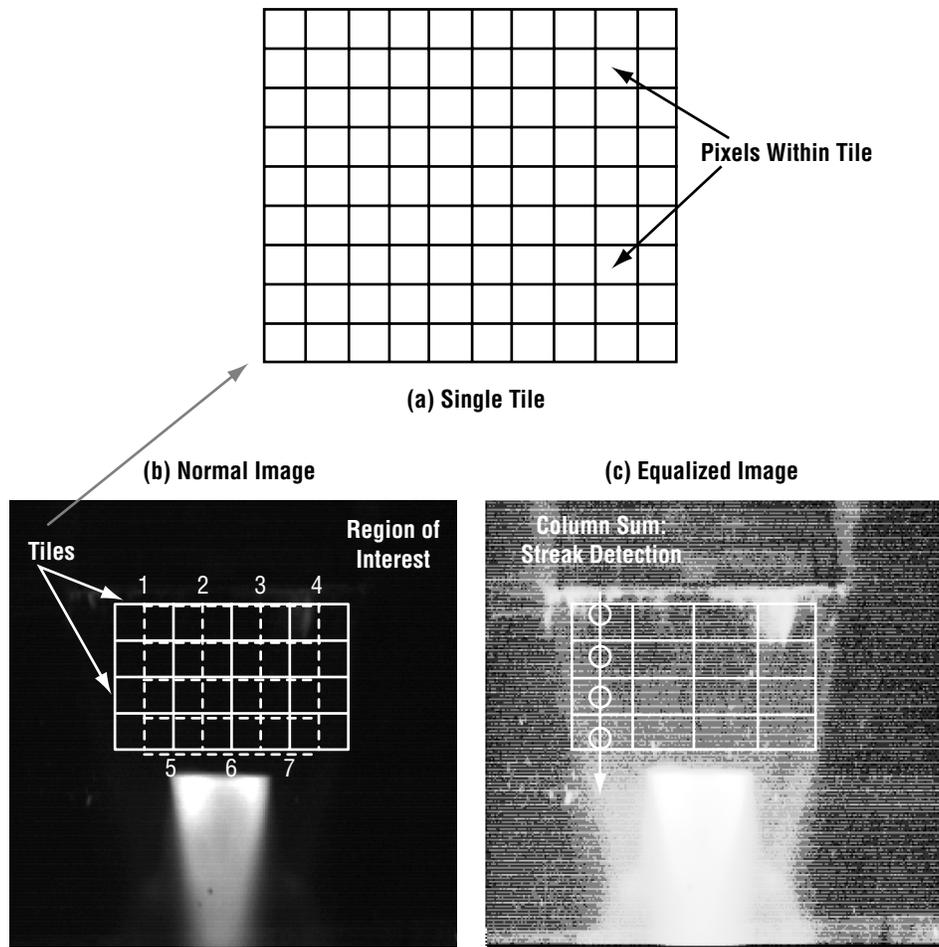
In the present configuration, a system of seven overlapping columns of tiles, extending between the engine nozzle exit plane and the Mach disc, are used to determine whether a streak has occurred. Figure 7(b) shows this seven-column configuration with a normal HSO recorded image in which the Mach disc is exposed for the midrange of the camera. Four main columns of tiles cover the region of interest, as represented by the solid lines in figure 7(b) and (c). While a plume streak may occur on the boundary between two of these four main columns of tiles, it was empirically determined that the intensity change due to a streak along a tile boundary is not always sufficient to indicate an out-of-family tile. However, streaks recorded in the center of a tile do yield a sufficient intensity change to indicate an out-of-family tile. To avoid missing these boundary streaks, three additional columns of tiles are used—dashed lines in figure 7(b). The centers of these three additional columns cover the intersecting boundaries of the four main tile columns.

Processing of each column begins at the nozzle exit plane, moving toward the Mach disc, as shown in figure 7(c). Figure 7(c) is an equalized image that permits observation of the plume boundary and nozzle exit plane. The main columns are processed first, followed by the overlapping columns. If each tile in a column has tile value “1,” the column is said to contain a streak. If there is at least one tile in a column whose tile value is “0,” the column is said to not have a streak. If a tile is encountered that has a value of “0,” processing stops on that column and begins on the next column. The column location, size (number of columns), number of frames, and the duration of each streak are recorded.

Figure 7. Streak detection elements.

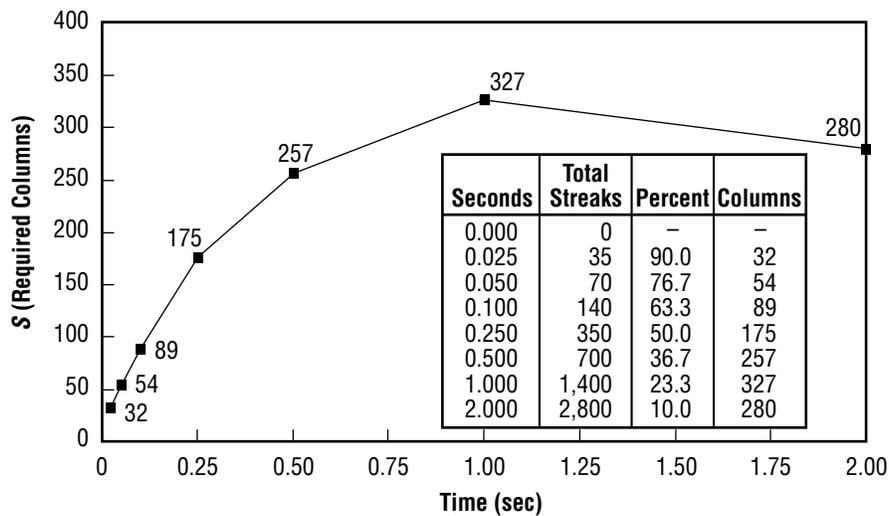
At any instant in time, a percentage of $S_{\tau, \max}$, denoted S_τ , is used as the threshold value to check for an anomalous condition and is a function of observation time, τ . For a full 2-sec time interval, 10 percent of $S_{\tau, \max}$ is used; and for the time delay period, 25 msec at 200 fps, 90 percent is used. The number of columns required for redline violation for time checkpoints between 25 msec and 2 sec is obtained by evenly distributing percentage values from 90 percent at the time delay value to 10 percent at the 2-sec value.

The interpolated values for the number of columns required for redline violation versus time period are shown in figure 8.

Figure 8. Number of required columns for redline violation with 200-fps camera.

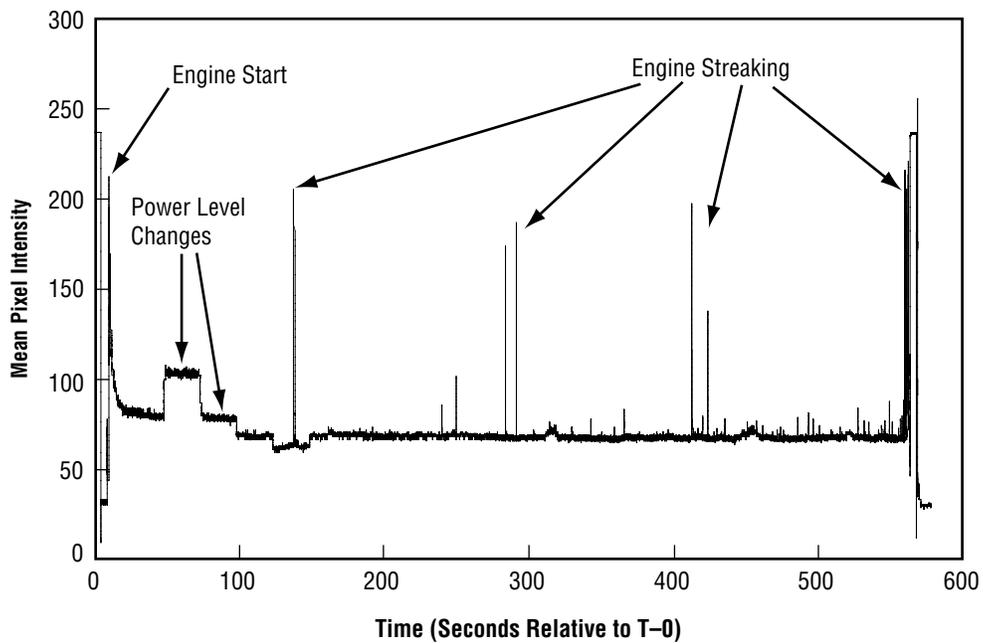
This SSME test was performed on January 25, 1996, at SSC on test stand A1. A number of large streaks were visible during this test. The test was cut off early by a human observer and the engine suffered damage. Videotape of this SSME test was used to develop the HSO expert system. Figure 9 shows the mean plume intensity during SSME test 901–853. Streaking induces a plume brightening and this greater intensity is noted as plume streaks in figure 9.

Figure 9. Test 901–853 mean plume intensity.

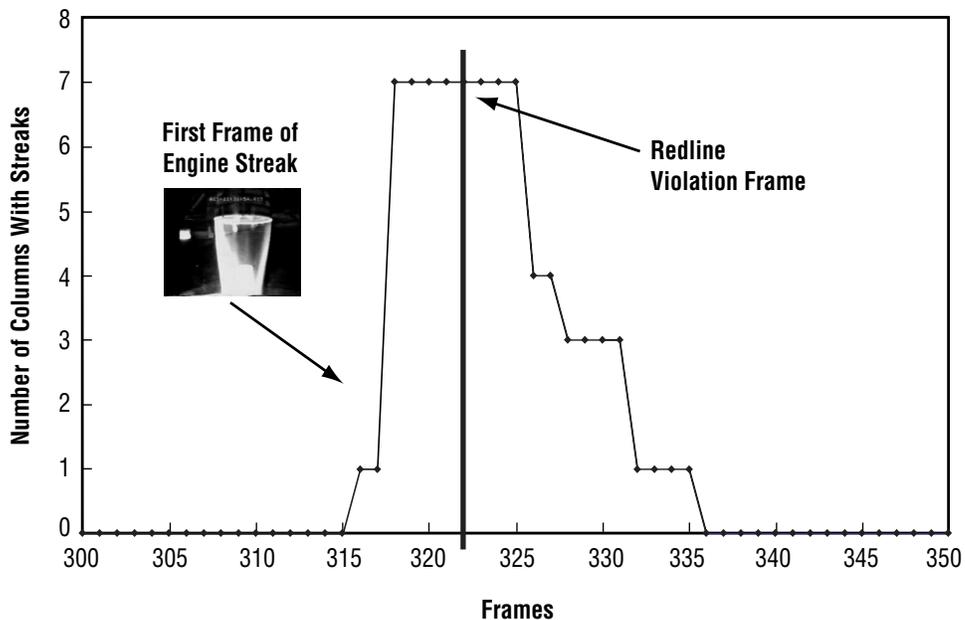
Figure 10 provides a magnified view of the HSO analysis for the first streak occurring at ≈ 140 sec. A redline violation occurs and was noted by the HSO expert system. The number of columns with streaks together with the continuing nature of the streaking during the five frames preceding the bold black line in the center of figure 10 produced a redline violation within 25 msec at frame 322.

Figure 10. HSO analysis of first streak phenomenon for SSME test 901–853.

Frame acquisition rate: 200 fps

Image size: 256×256 pixels

Region of interest: 21 tiles in 7 columns, 3 rows, 3 overlapping columns

Size: 31×47 (1,457 pixels)

Threshold: 48

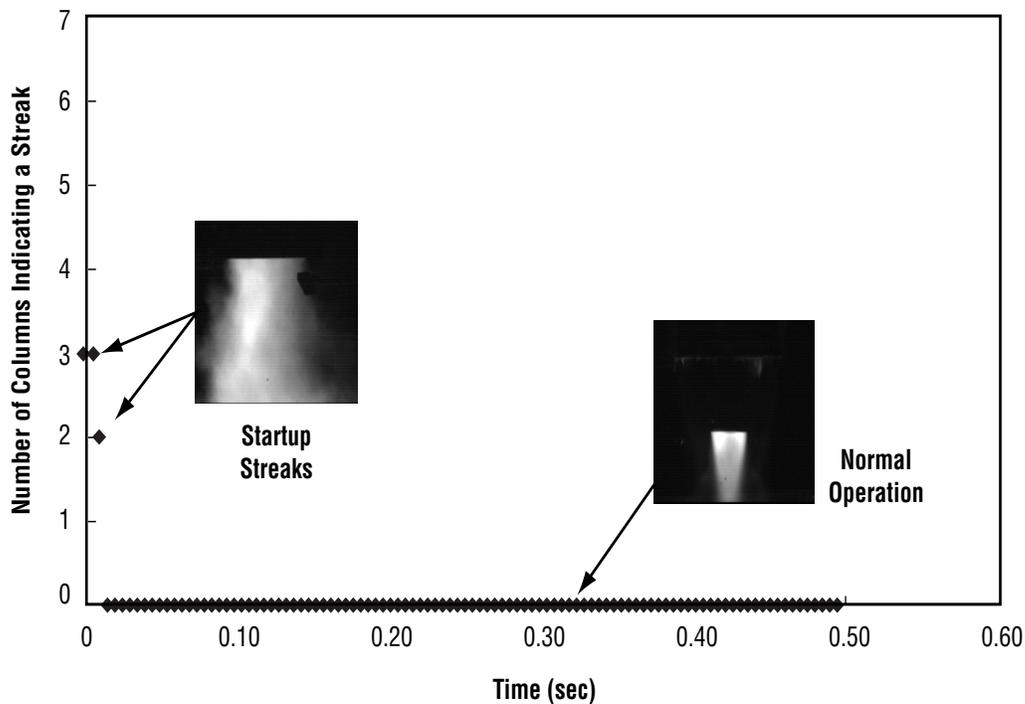
This SSME test occurred at the B1 test stand at SSC on September 3, 1998. Two streaks were detected in the early startup phase, but no streaks were detected after that, as shown in figure 11. Test duration was 750 sec.

Engine startup produces a situation where tile values indicate streaking. From the initial testing phase at SSC, it was determined that the expert system should be engaged only after mainstage is attained.

Figure 11. HSO analysis of SSME test 904–361 streak data from first 440 frames.

Frame acquisition rate: 207 fps

Image size: 256×256 pixels

Region of interest: 21 tiles in 7 columns, 3 rows, 3 columns overlapping

Size: 31×46 (1,426 pixels)

Threshold: 16

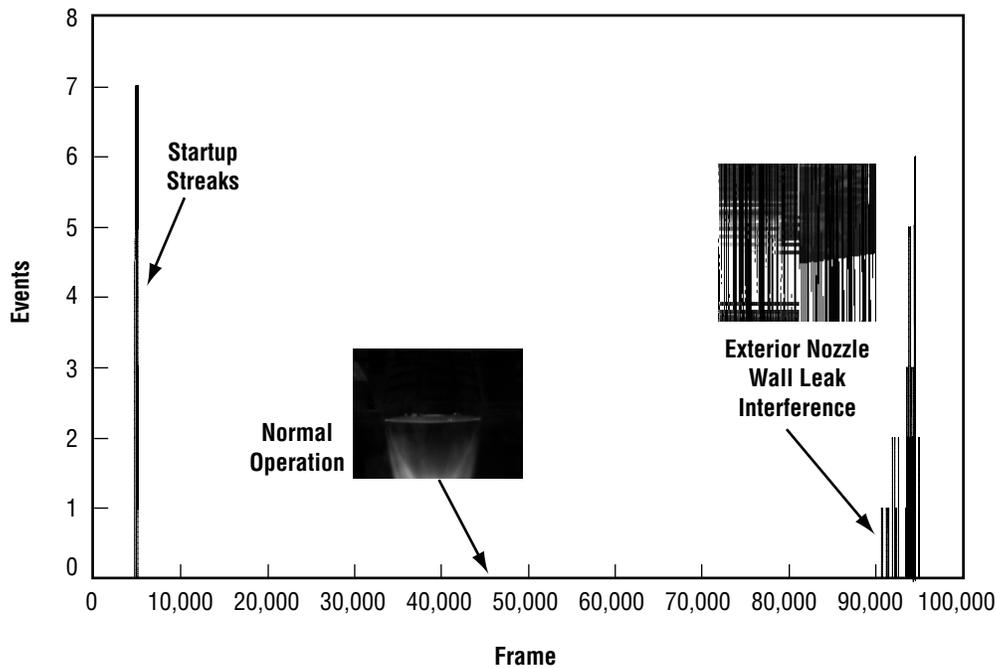
This SSME test occurred at the A1 test stand at SSC on August 23, 1997. As shown in figure 12, there were numerous streaks detected early in the startup phase but no anomalous streaks were detected. The camera was in the direct path of an exterior wall nozzle leak and the data were unusable after the camera malfunctioned due to overheating. Another problem experienced during the test was an incorrect exposure setting for the Mach disk. This overexposure caused the CCD array in the camera to bloom, a common phenomenon experienced in CCD array cameras when overexposed. To prevent this from creating false streaks, the camera is turned on the camera mount in such a way that the blooming effect is orthogonal to the direction of columns.

Figure 12. HSO analysis of engine test 901–932.

Frame acquisition rate: 175 fps

Image size: 160×160 pixels

Region of interest: 21 tiles in 7 columns, 3 rows, 3 columns overlapping

Size: 48×90 (4,320 pixels)

Threshold: 128
